WOKING PALACE

CONSERVATION MANAGEMENT PLAN

CONDITION SURVEY

CONDITION REPORT (DRAFT)

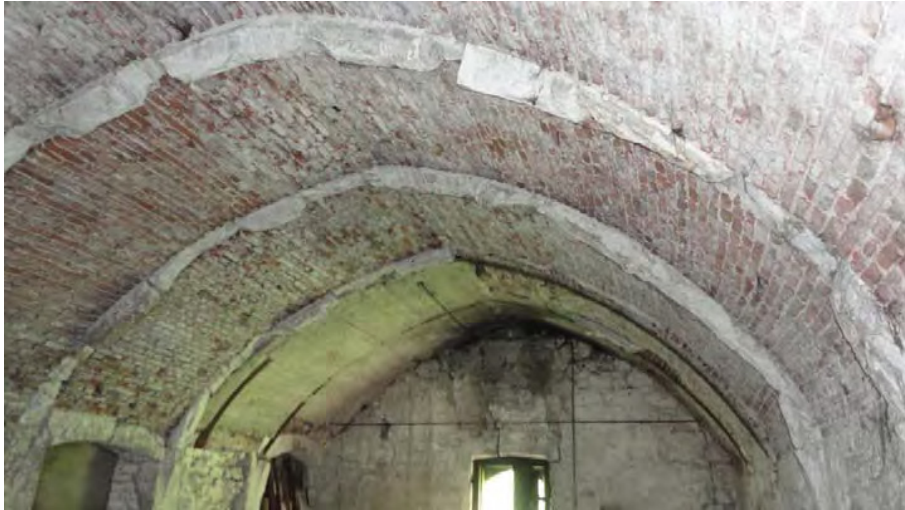
The moulded chalk clunch arch ribs are very badly fractured with the projecting section of the ribs being weathered back to the face of the brick vault in many areas (see below from east to west).

It is likely that this apparent fracture damage was caused over the centuries by frost action to the soft chalk emanating from water ingress through the top of the vault when there was no adequate protection from a temporary roof. There could also have been acts of vandalism. The vault is now adequately protected by a lightweight roof and the vault windows and doors are adequately sealed to keep out the weather. There is however a degree of fracturing to some areas of the stone ribs most notably the bottom of rib 4 northern spring point and falling sections of fractured rib have recently been reported by volunteers.

Figure 1. View of vaults looking East showing fractured chalk ribs and concrete repairs to end two bays of vault.

- Erect scaffold to inspect ribs for loose sections, make safe and consolidate ribs and edges of brick vault.
- Limewash/shelter coat ribs
- Resin inject cracks in brick vault
- Poultice brick vaults to remove salts/lime bloom
- Apply bituminous paint to iron springs and ties

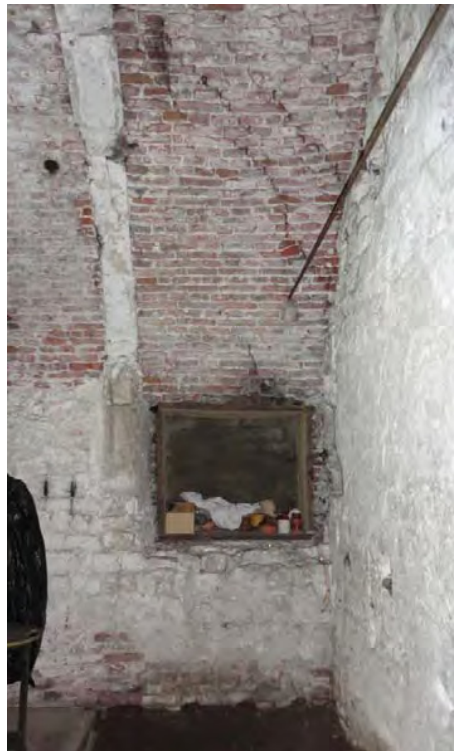
- Cracking through brick joints in south section of bay 6 probably caused when un-lintelled window opening was inserted in the 1920's.
- Cracking through brick joints in south section of bay 1.
- Cracking in north section of bay 6 where vault appears to have moved out slightly.
- Cracking through brick joint in north section of bay 5 due to window lintel settlement.
- Edge of brick vault abutting north section of rib 2 and 3 is exposed where stone ribs have weathered back beyond face of brick.
The 1920's concrete repair to the northern section of the vault in bay 1 and 2 appears to be sound and the iron spring supports appear to be sound and tight, however the iron is corroding and a thin crust of concrete on the face of the springs is likely to detach and fall presenting a possible hazard.

The unlimited window aperture has caused settlement cracking to the brick vault and has temporary timber shoring in the aperture.

Figure 2. Cracking through brick vaults in bay 6 caused by insertion of window without lintel in 1920's.

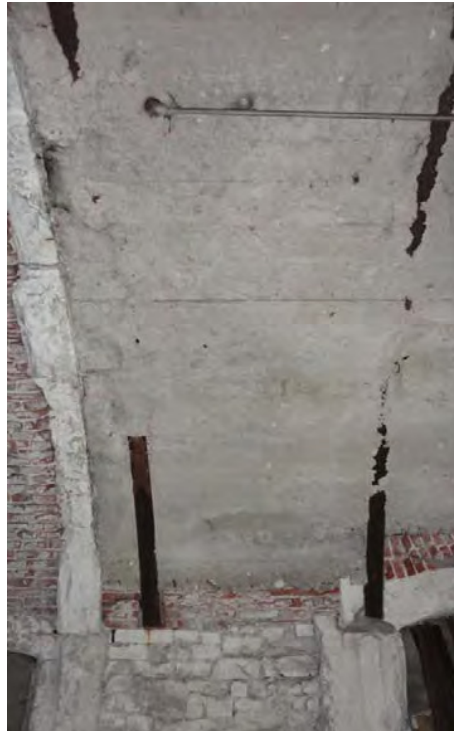
The cast concrete infill to the vault of bays 1 and 2 (at the east end of the building) although appearing stable would benefit visually in the long term by replacement with brick.

Figure 3. Circa 1920's replacement of brick to northern section of vault bay 1 and 2 with in situ concrete. Thin layer of concrete to face of rusting steel springs could detach.

- Carry out conservation repair and reinstatement to damaged ribs and springing stones.
- Remove concrete section of vault and reinstate with brick.

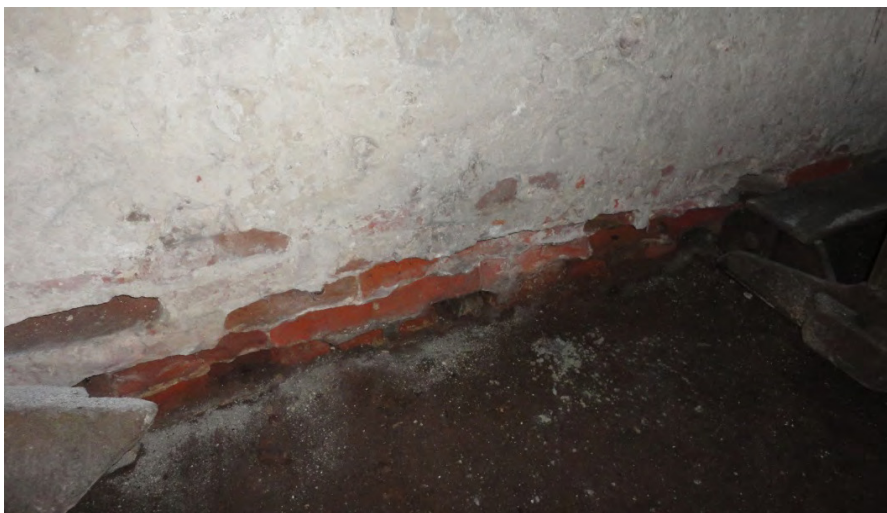
Figure 4. Eroding bricks to plinth within vault chamber caused by ground water at base of wall exacerbated by water falling from eaves.

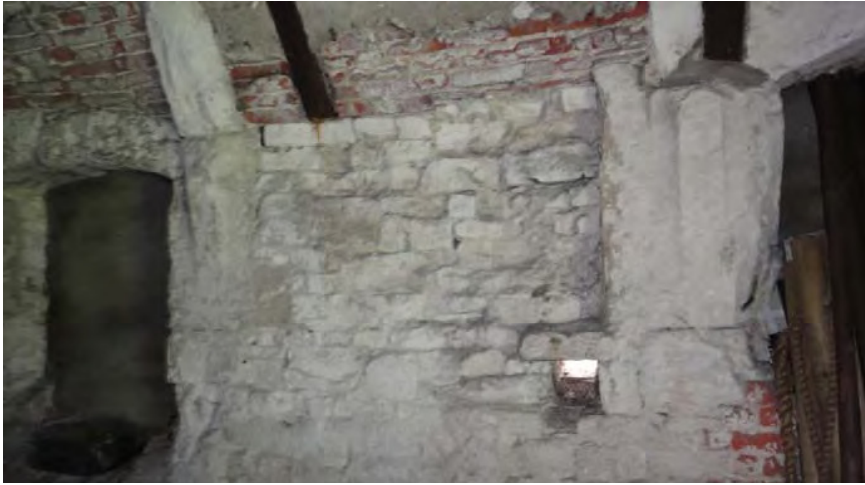
Figure 5. Good example of intact chalk spring stone and small vent opening.

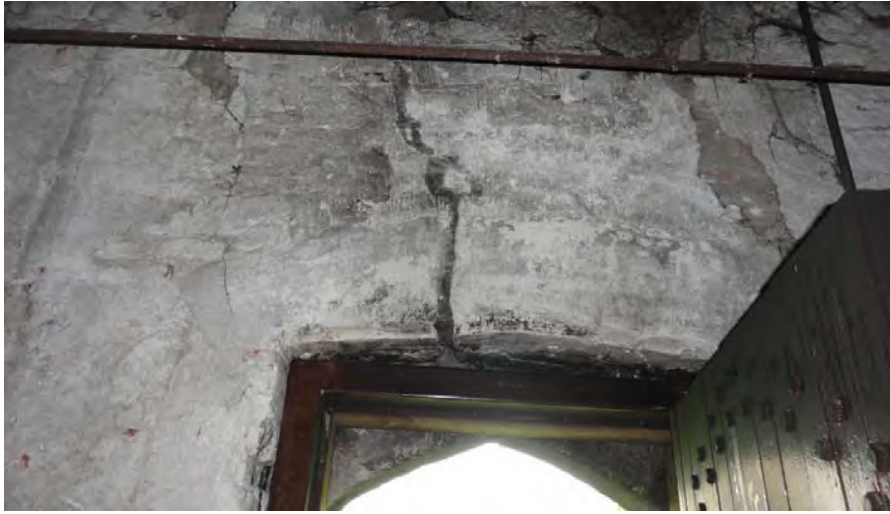
The chalk and brick appear to be well pointed and the slurry coat is only intact up to 2/3 height. There are several eroded bricks to the plinth and three previously filled vertical cracks above the door, the central crack continuing through the lintel. The bottom of the southern door joint has a void in the masonry and there is a vertical crack/void to the south end of the wall.

Figure 8. Previously filled cracks above door in East Elevation.

- Cut out and piece in 18 no eroded bricks to plinth
- Cut out and refill 3 no. cracks and slate pack lintel end.
- Consolidate vertical crack to south end of wall
- Apply lime slurry coat to top part of gable and limewash all wall

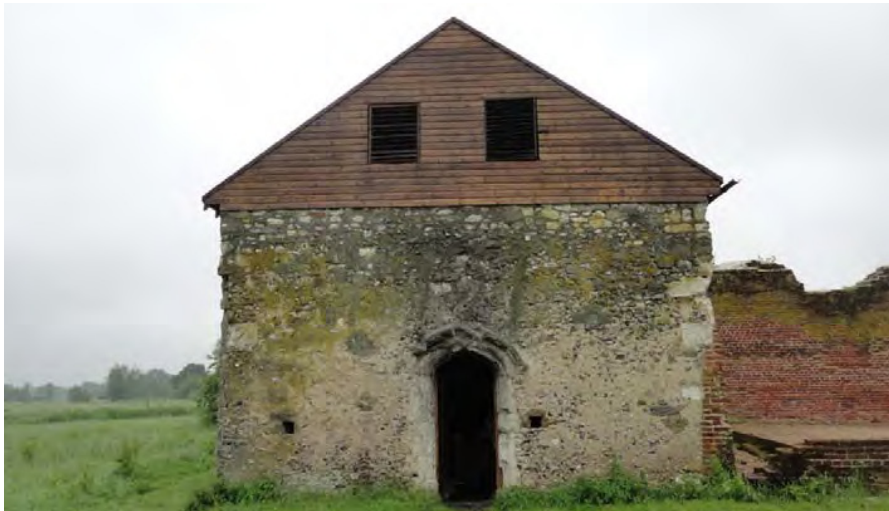
Figure 9. East Elevation of Vaulted Building showing hard cement mortar packing to upper section of elevation.

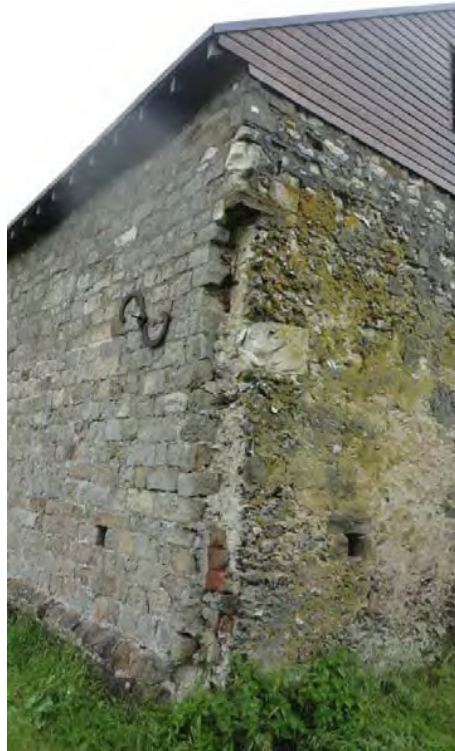
Figure 10. Missing stack of masonry from South East corner of Vaulted Building.

- Re-point open joints to plinth.
- Re-build missing corner with brick and lime render finish

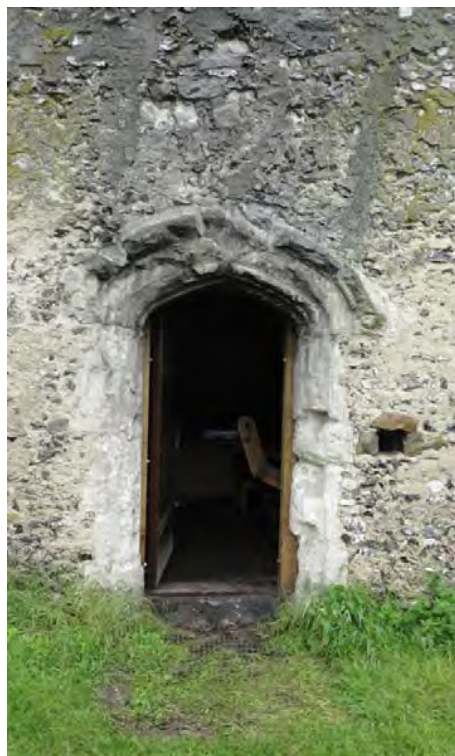
The 14th century moulded chalk door surround has suffered from mechanical damage especially the hood moulding and the lower right hand jamb.

Figure 11. 15th century moulded chalk door surround to South East Elevation with Lime Shelter Coat finish.

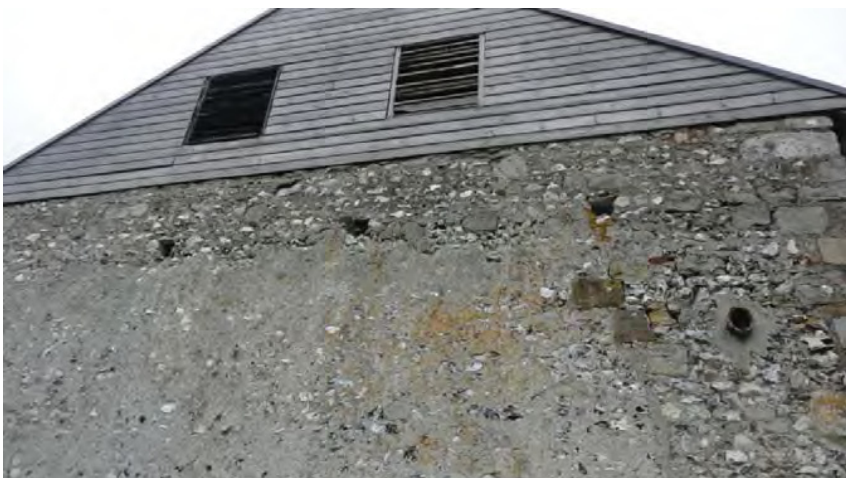
Figure 14. West Elevation of Vaulted Building showing hard sand cement mortar packing to upper section of flint walling and degrading timber louvers.

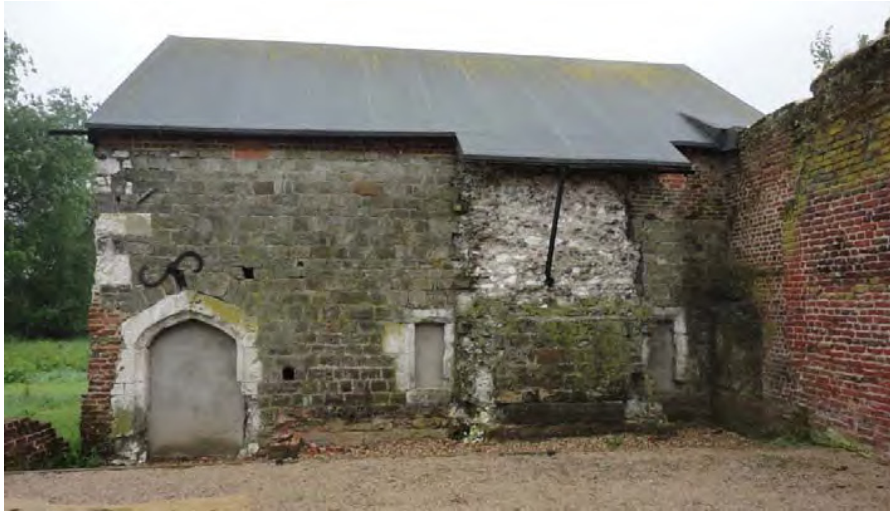
The felt roof and photovoltaic cells appear to be in good condition, however the upvc gutters on the north elevation have become detached either due to winds or vandalism and water is discharging onto the projecting chimney breast. Likewise the open ended gutter at the east end is discharging directly onto the low wall remains below. The rainwater discharge will be contributing to the erosion of the internal plinth brickwork. The 4 no. timber louvers are degrading and the shiplap boarding requires staining.

Figure 15. North Elevation of Vaulted Building showing algae growth on walls due to damaged and inadequate gutter system.

- Replace UPVC gutters with black polyester powder coated cast aluminium eaves gutter with stop ends to north and south elevations with outlet pipes projecting 90° to gutter to throw water well clear of north and south elevations.
- Replace 4 no. timber louvres and re-stain shiplap boarding.

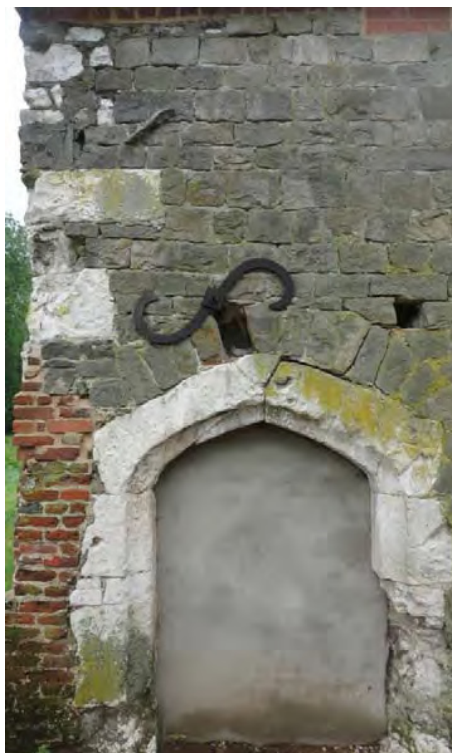
The moulded limestone door surround is degraded at the bottom right hand jamb and one half of the arched lintel stone has various cracks and has slightly settled. There is a missing Heathstone from the relieving arch above the door moulding.

Figure 16. Cracked and settled moulded chalk door lintel on North Elevation of Vaulted Building and missing Heathstone voussoir to relieving arch.

- Pin cracks to 3 no. lintels with stainless steel pins set in resin and point cracks.
- Piece in 1 no. Heathstone to relieving arch.
- Re-point open pockets in masonry in isolated areas.
- Replace 1 no. chalkstone window cill.

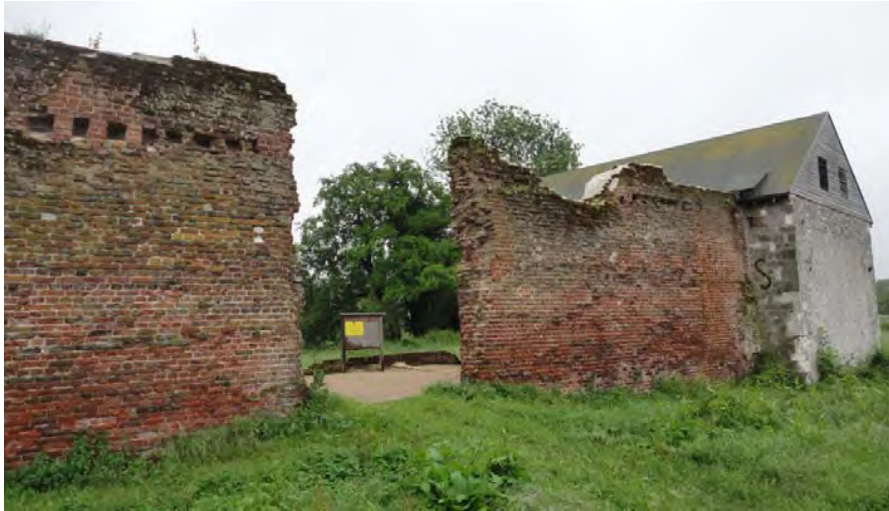
The wall heads appear to have been capped with white cement sand mortar which although protecting the wall head from water ingress has the effect of congregating rain water run-off onto the upper faces of the facades which attract algae growth and will suffer from frost action. It is suggested that a projecting soft turf capping may be beneficial to act as a sponge to prevent rainwater run-off, protect the wall head from water ingress and be sympathetic to the setting of the building. The walls heads being accessible from a ladder will allow maintenance of the soft capping to weed out any self-seeded saplings.

Figure 17. West Elevation of Service Building Wall remains showing unsightly white cement mortar capping to wall head and dampness concentrated at wall head due to rainwater run-off.

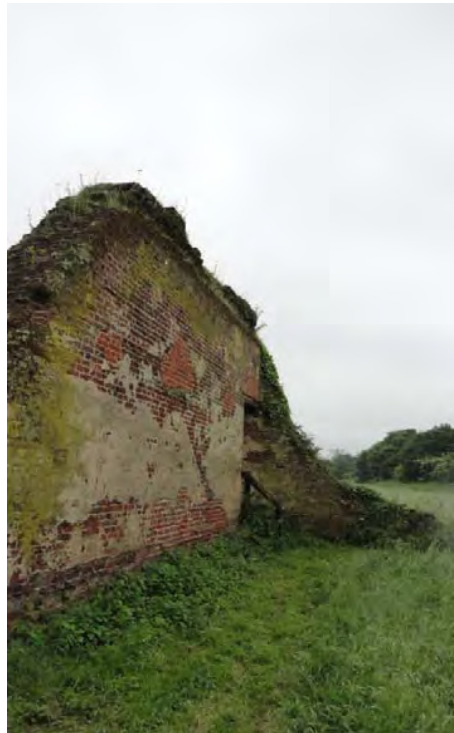
Figure 22. North Face of North Wall of Service Building showing remnants of thin cementitious render and algae caused by rainwater run-off from hard capped wall head.

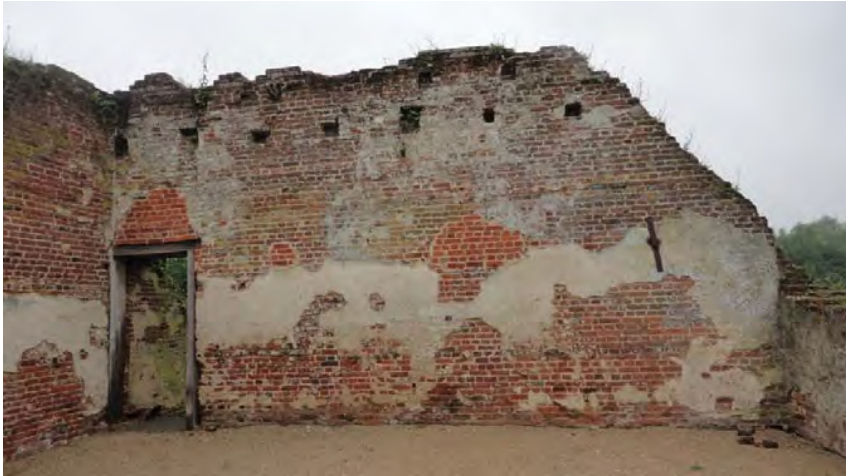
Figure 23. South Face of North Wall of Service Building showing remnants of thin lime render which has hollow sections, recently patched in areas of new handmade brick and new oak lintels, props and brickwork to doorway.

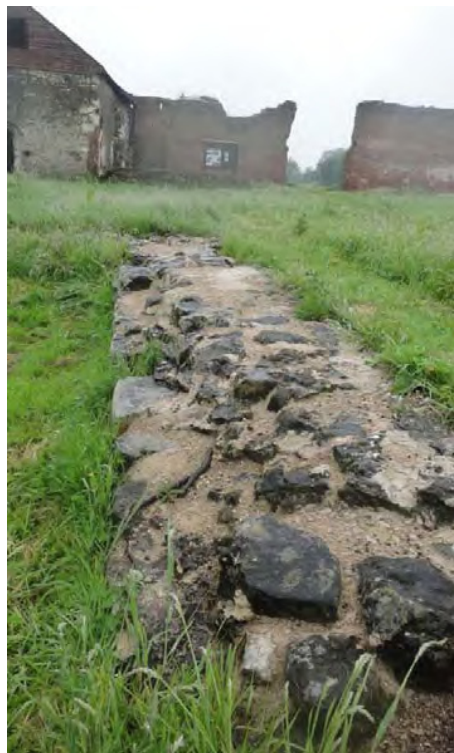
The lime mortar that has been used to consolidate the exposed walls have been fractured by frost action and unless hard mortar is used it is likely that further frost action to the mortar will be likely. It is therefore recommended that an NHL5 (eminently hydraulic lime) is used to consolidate the wall heads and on-going repointing is programmed.

Figure 26. Low wall head remains to South End of Great Hall that have been consolidated with lime mortar that has been degraded by frost action.

- Carry out repairs/reconsolidation to wall heads.

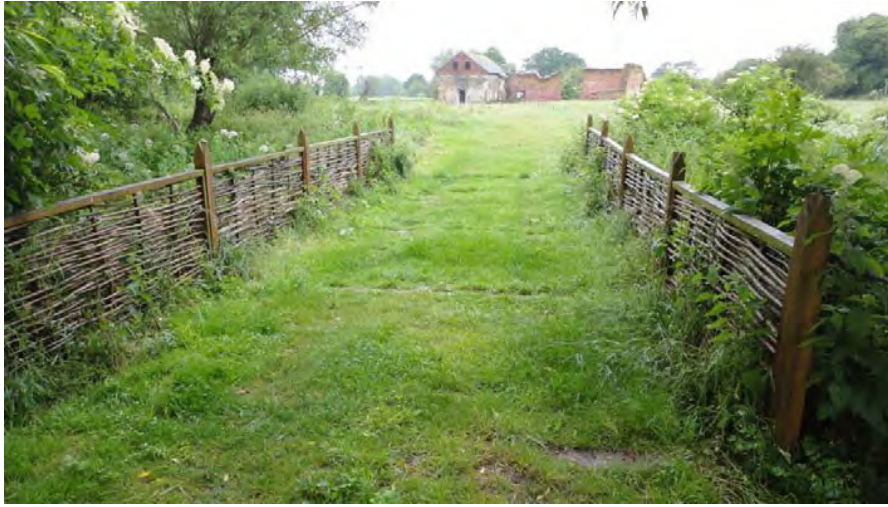
Figure 27. Hazel balustrading and timber bridge with grass topping at entrance to site.
