PURCELL

WOKING PALACE CONSERVATION MANAGEMENT PLAN

January 2016

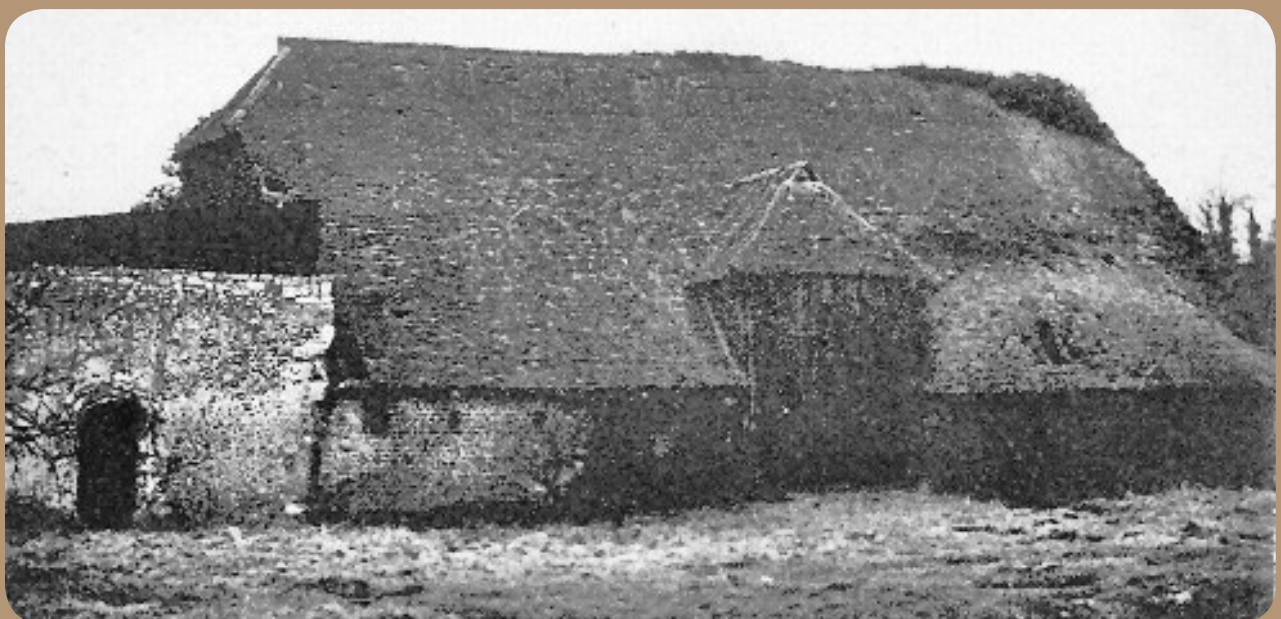
View of barn and vaulted room from north west, believed to be c.1905. Note intact roof to barn building and monopitch roof to vault. (Reproduced by permission of Phillip Moll).

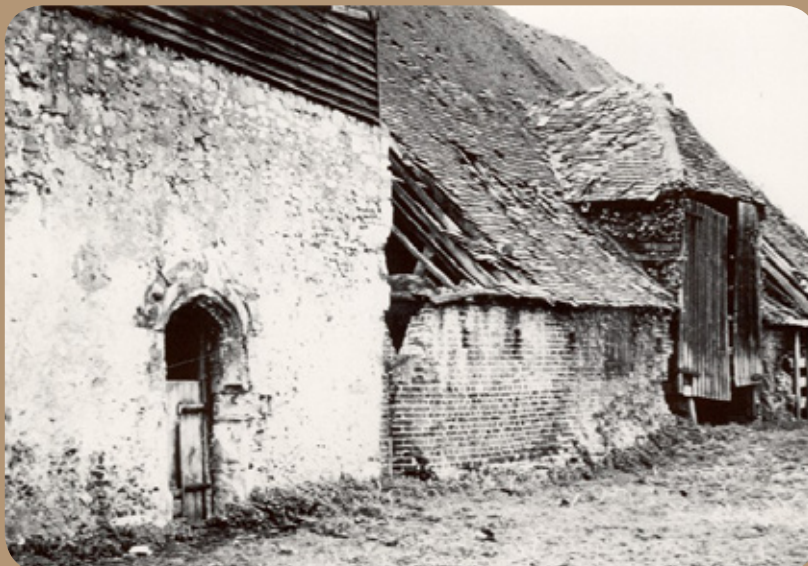
View of barn and vaulted room from south east, c.1945. Note intact roof to barn building and monopitch roof to vault. (Reproduced by permission of Phillip Moll).

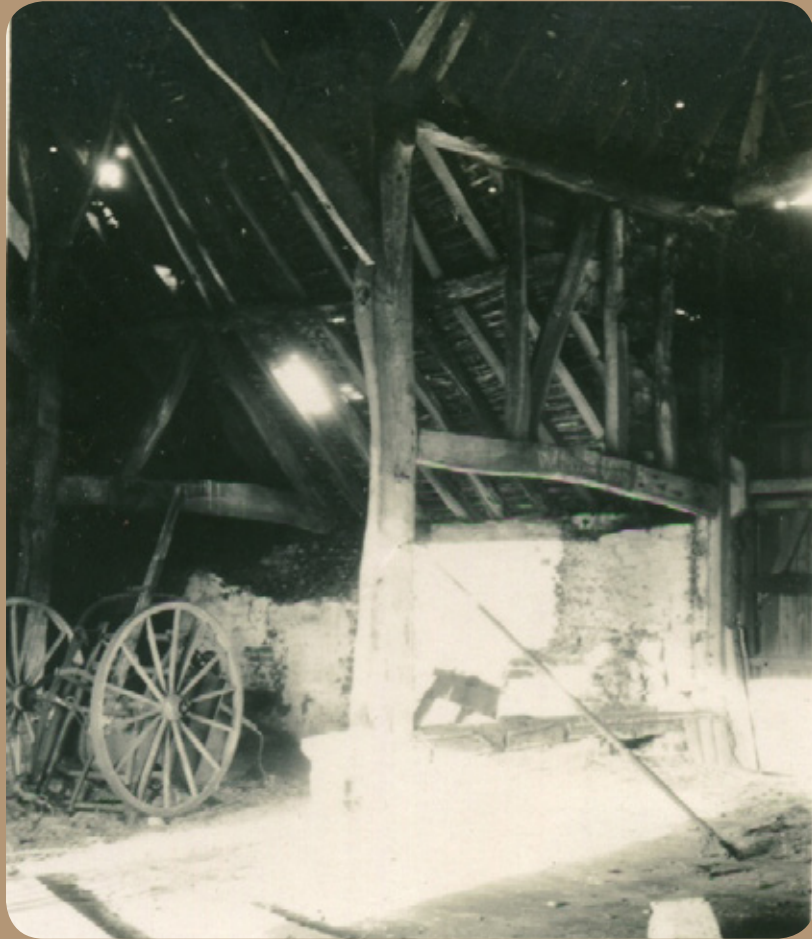
View of barn interior: 1948. Note intact roof. (Reproduced by permission of Les Bowerman).

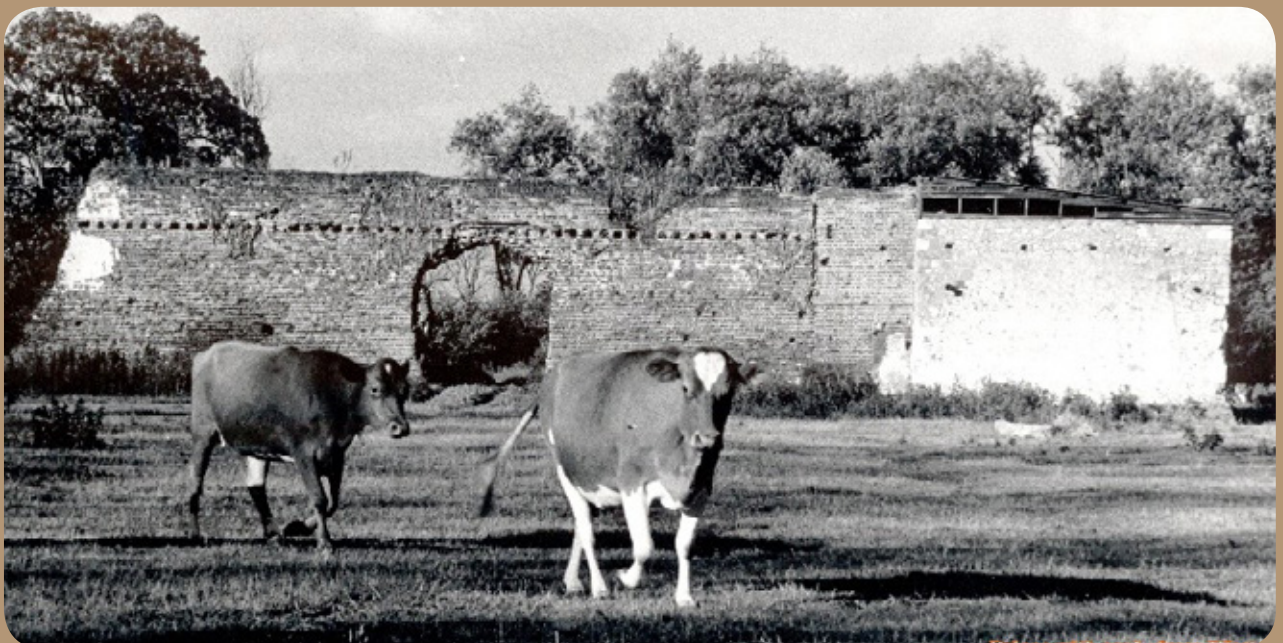
View of Palace from west. c.1985. Note intact monopitch roof to vault. (Reproduced by permission of Phillip Moll).

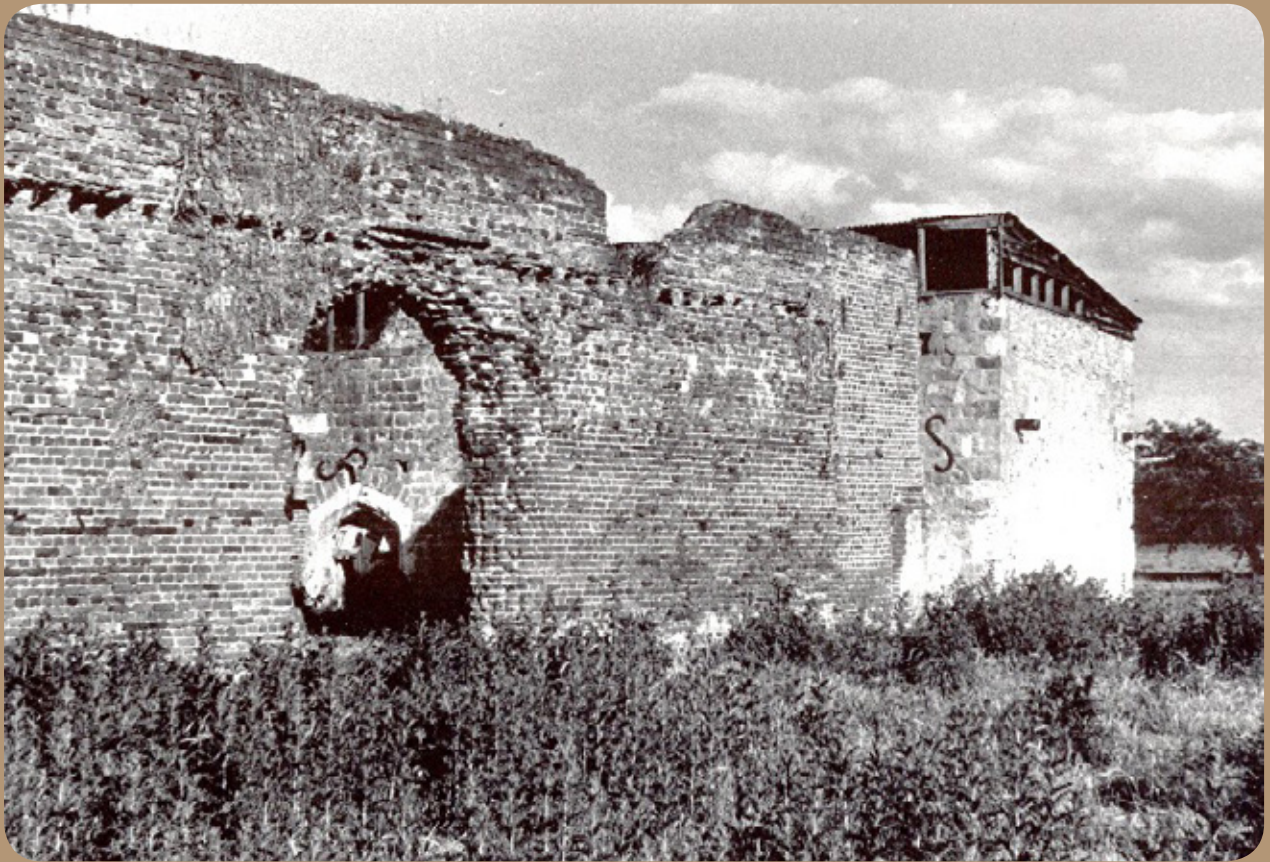
View of Palace from north west. c.1985. Note intact monopitch roof to vault and brick arch. (Reproduced by permission of Phillip Moll).

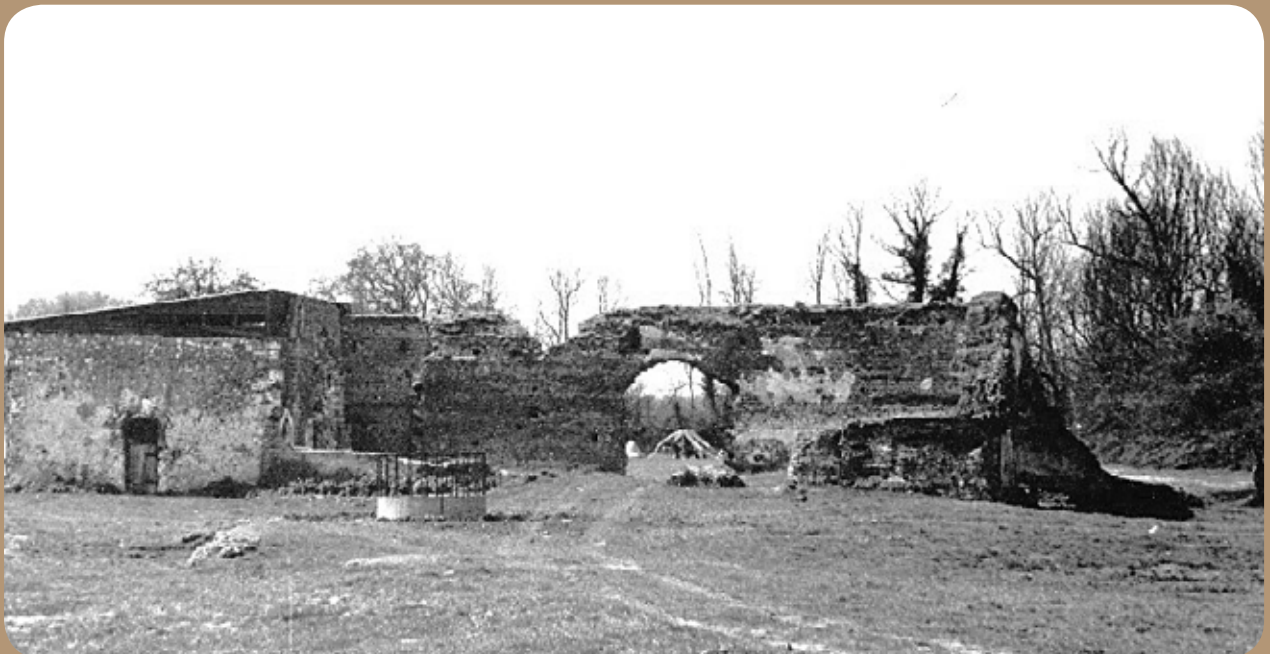
View of Palace from east. c.1985 Note intact monopitch roof to vault and brick arch. (Reproduced by permission of Phillip Moll)

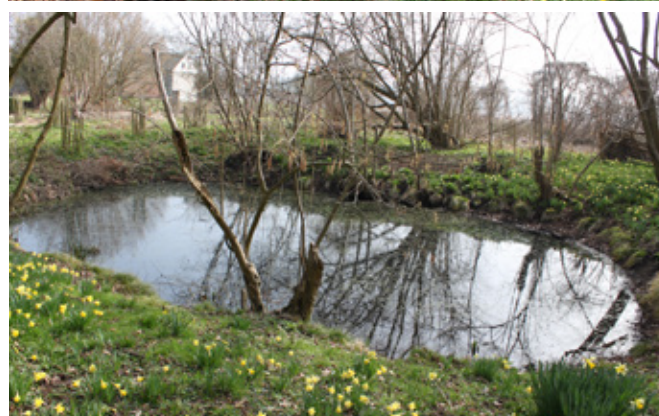
View 5 (C): View of water feature. This is presumed to be of mid-20th century derivation, being absent from the 1936 Ordnance Survey.
