WOKING PALACE

CONSERVATION MANAGEMENT PLAN

CONDITION SURVEY

CONDITION REPORT (DRAFT)

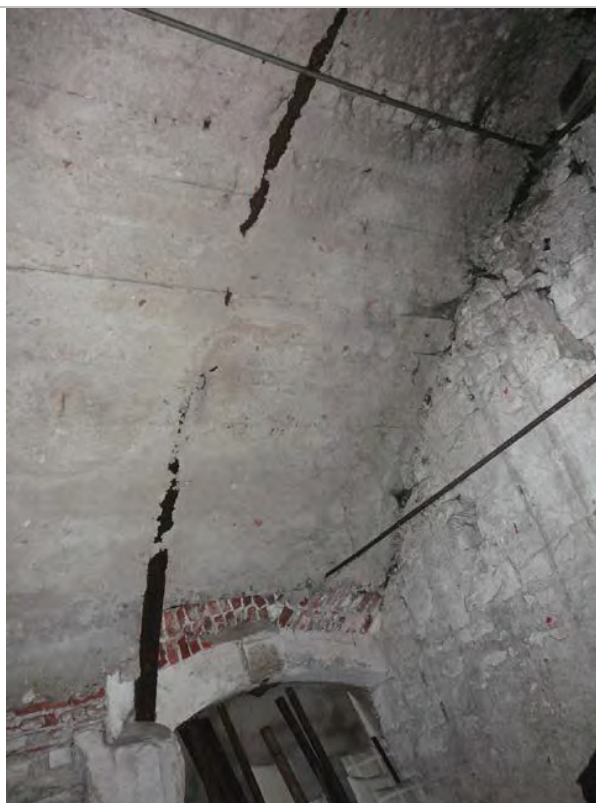
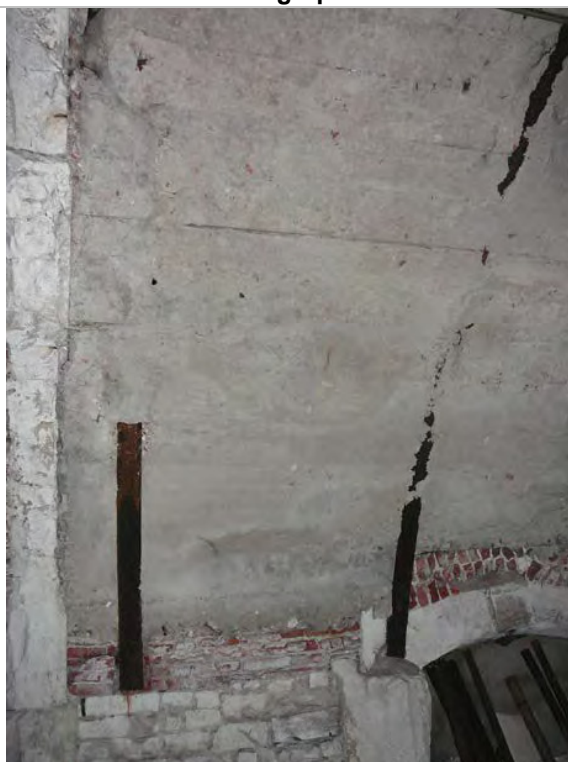
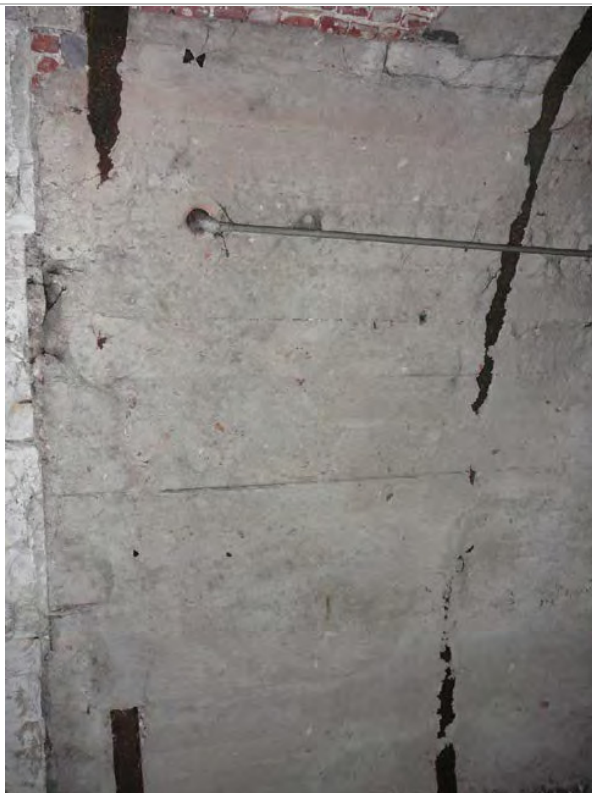
- 3.1.1 The undercroft consists of 6 bays running from east to west with 5 chalk clunch vault arches separating brick vaults. The north section of the first vault arch no longer exists, nor does the brick vaulting on the north side of the first 2 bays. All has been replaced by concrete with iron bands (photographs 1, 2 & 3).

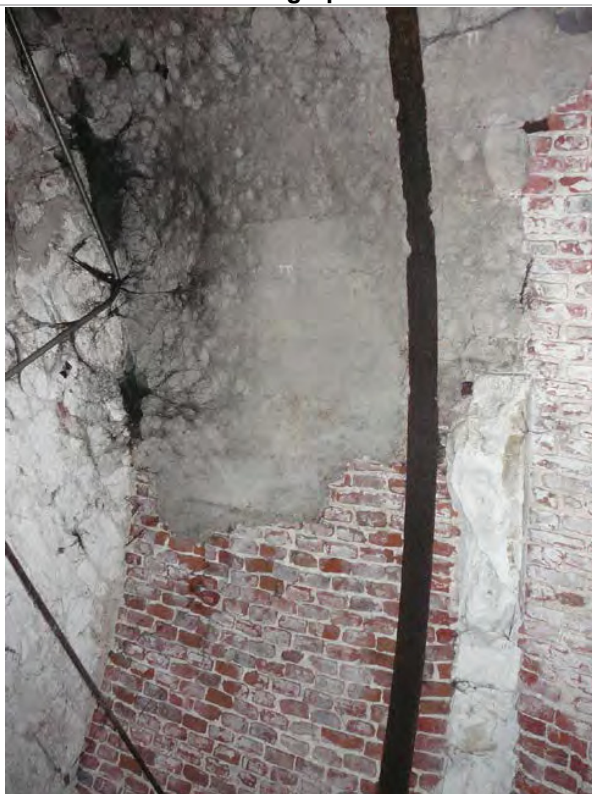
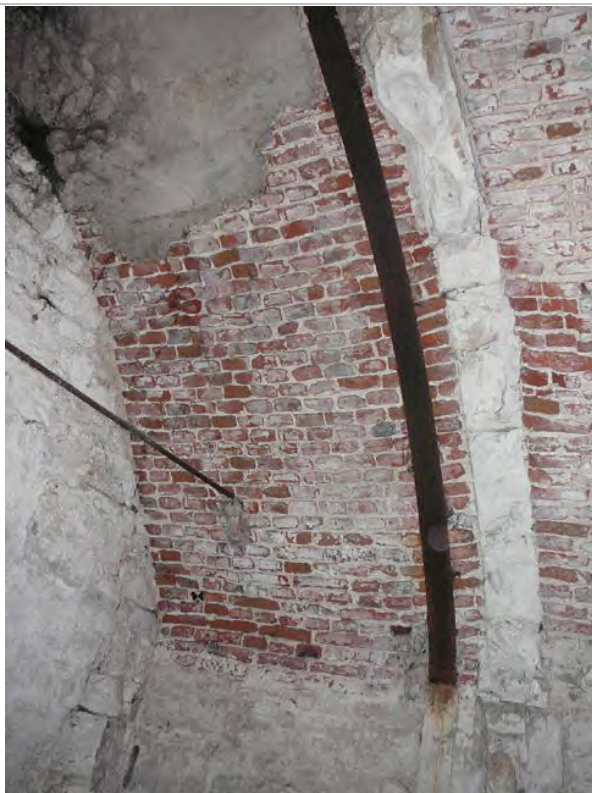
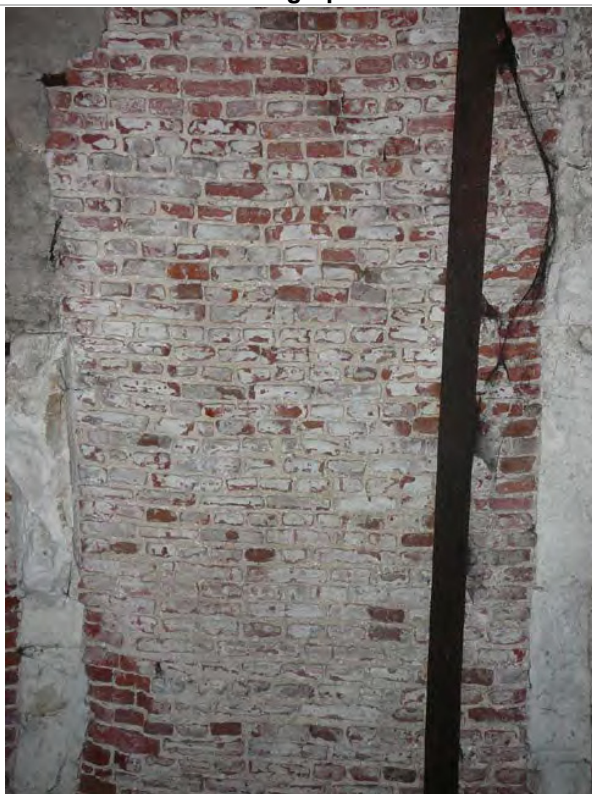
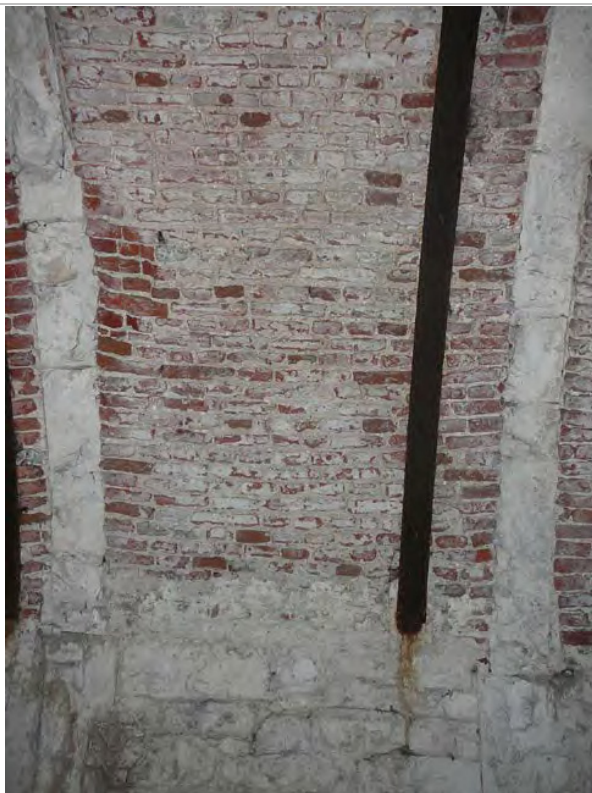
- 3.1.2 The brick vaulting of bays 1 and 2 on the south side appears to be in good order (photographs 4, 5, 6 & 7)
- 3.1.3 The brick vaulting to bay 3 appears to be in good order (photographs 8, 9, 10 & 11).

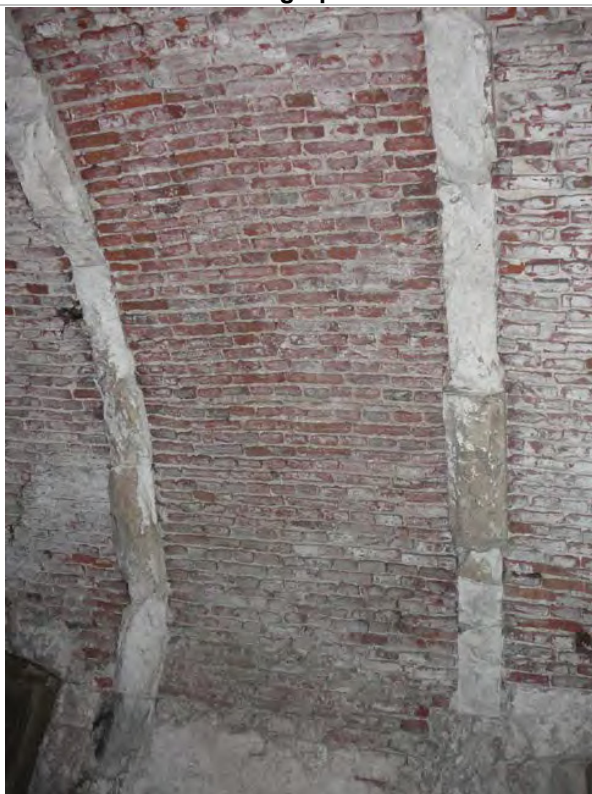
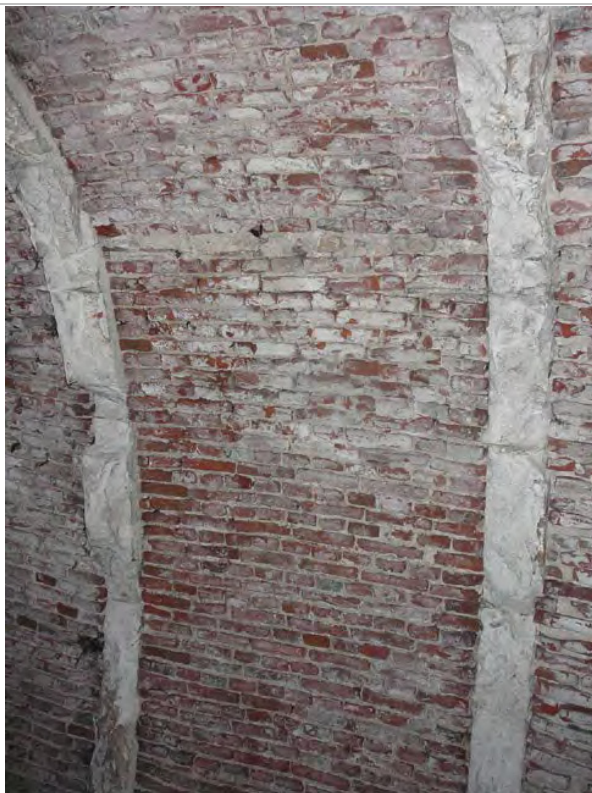
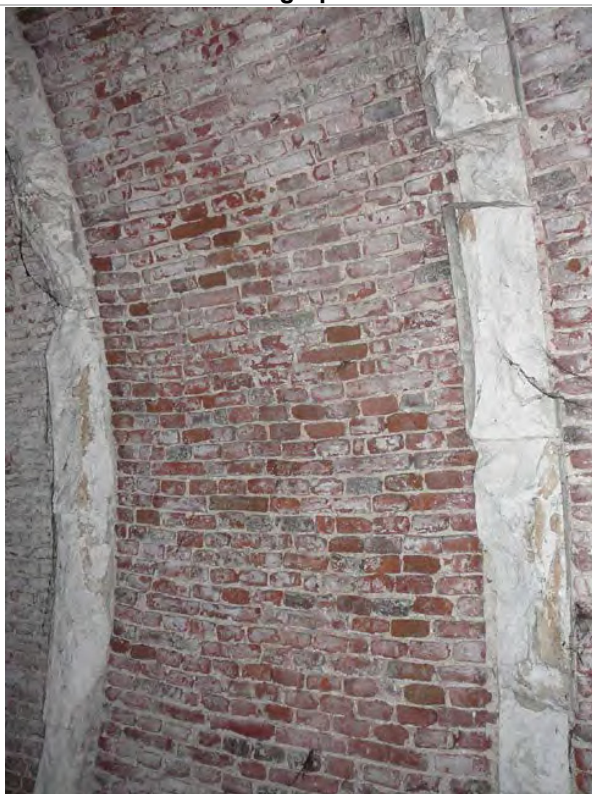
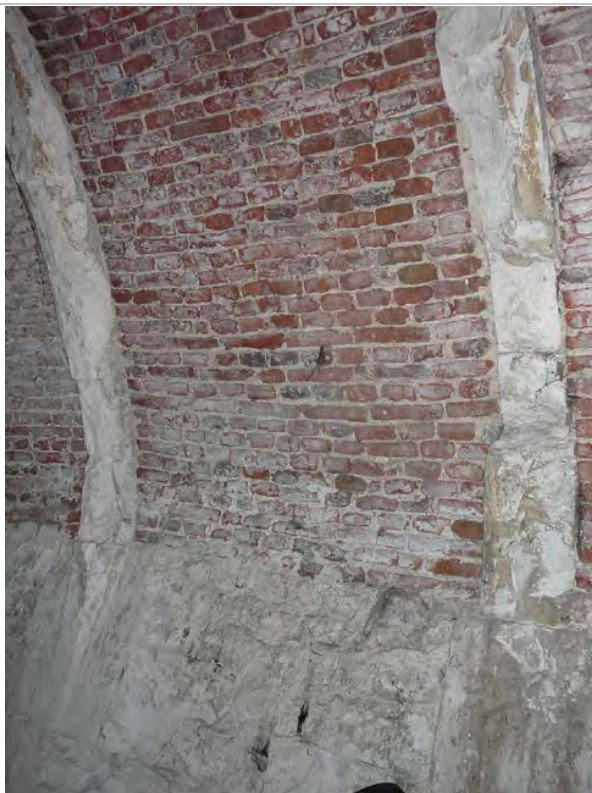
- 3.1.4 The brick vaulting to bay 4 appears to be in good order (photographs 12, 13, 14 & 15)
- 3.1.5 On the north side of bay 5 the lintel to the doorway has cracked and moved. This has caused the brick vault to crack and we recommend that this be injected with polyester resin (photographs 16 & 17).

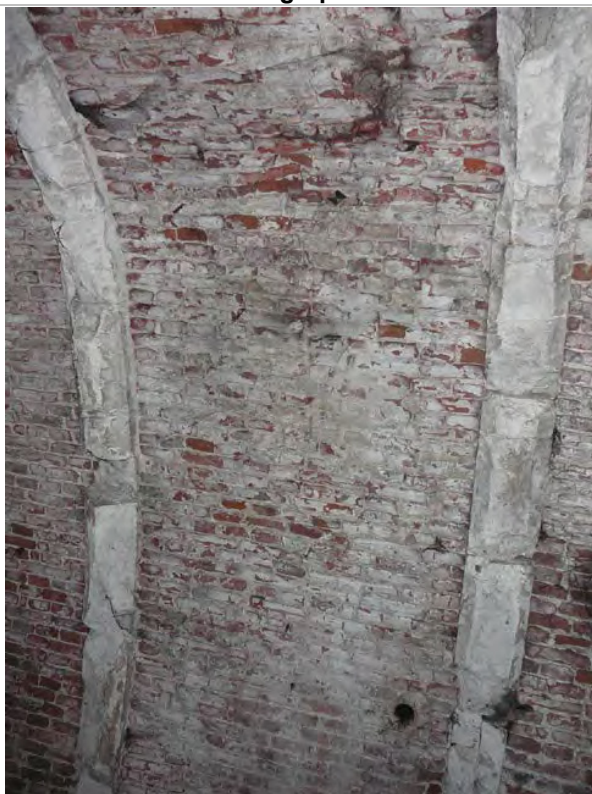
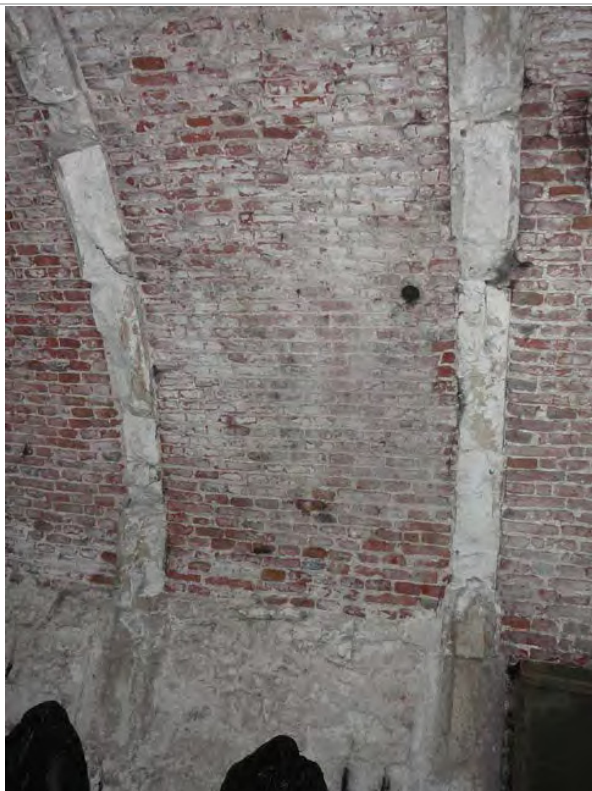
- 3.1.6 The brick vault on the south side of bay 5 appears to be in good order (photographs 18 & 19).

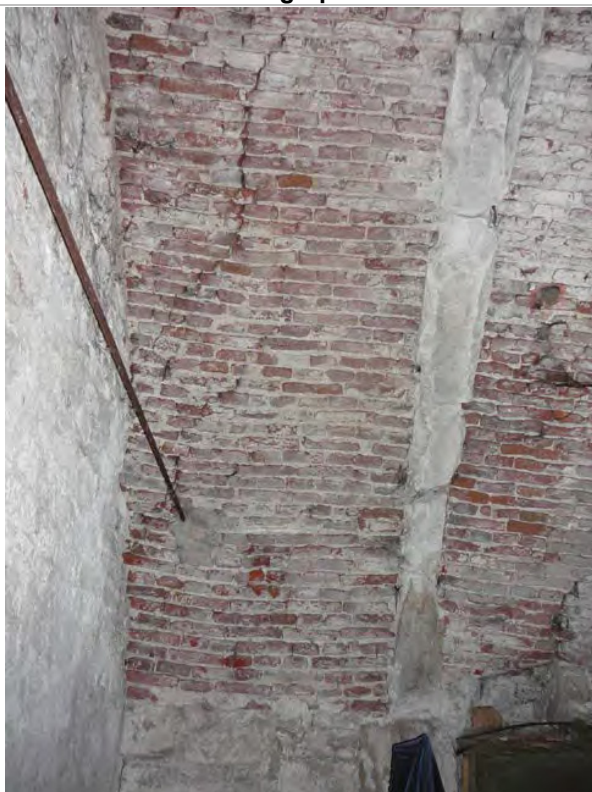
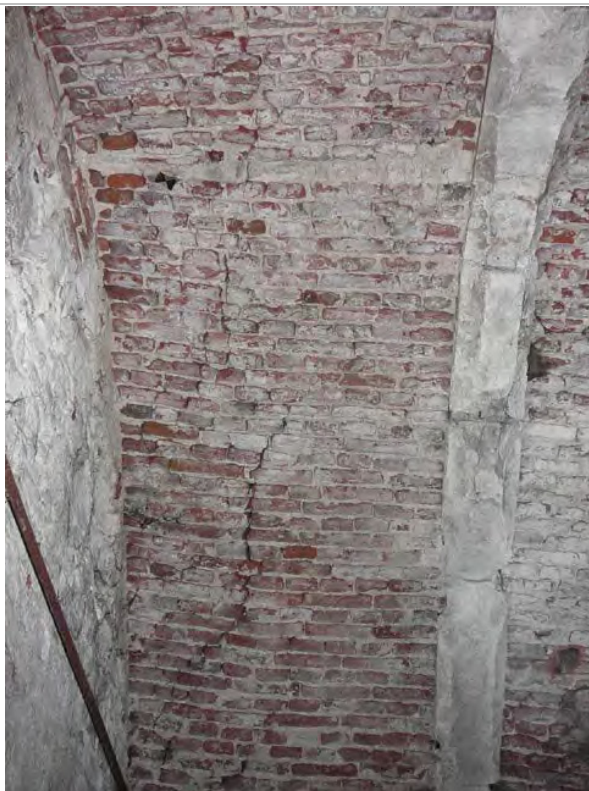
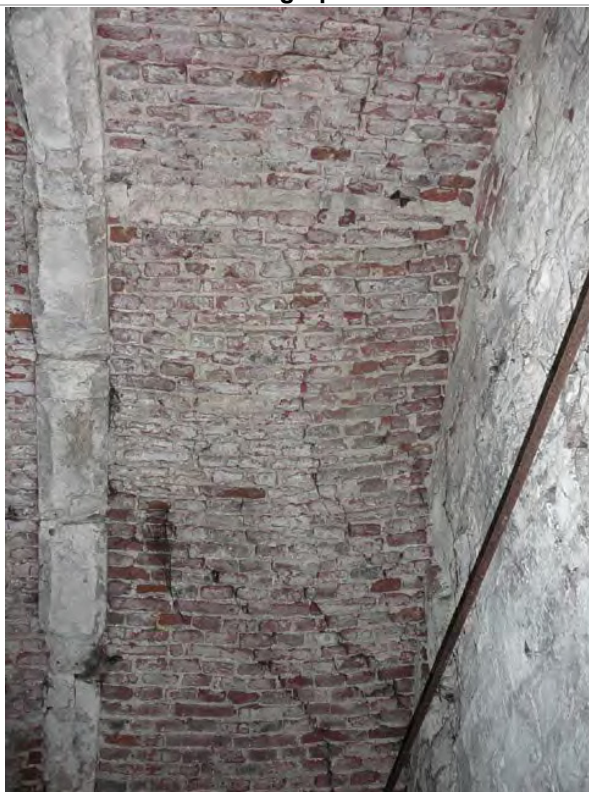
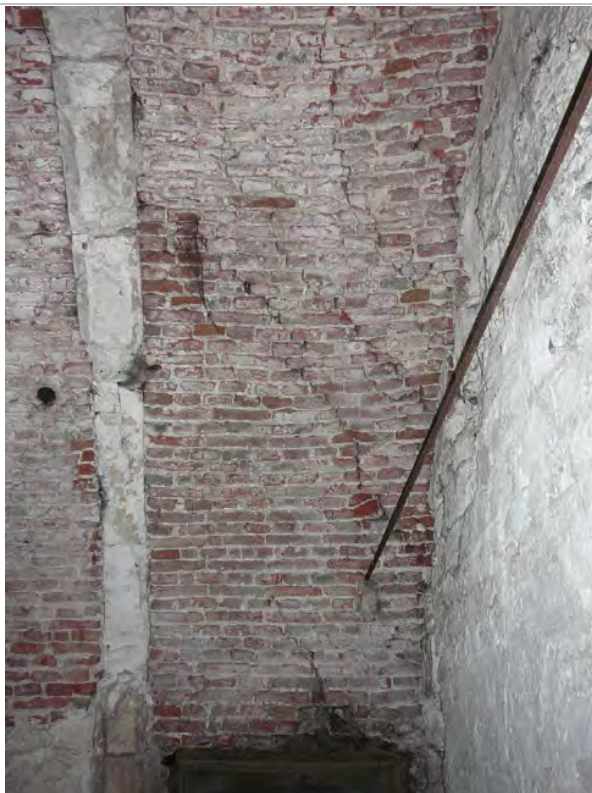
- 3.1.7 The brick vault on the north side of bay 6 has settled above the spring point on the wall and this appears to have caused longitudinal cracking in the vault (photographs 20 & 21). These cracks continue across the crown of the vault and then appear as diagonal cracks where a window has been inserted without the insertion of lintels (photographs 22 & 23). These cracks too should be injected with polyester resin.

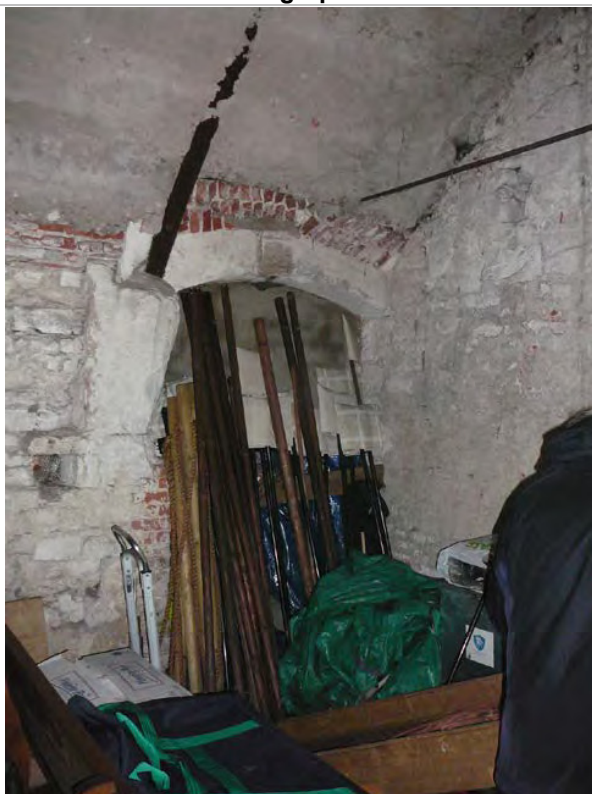
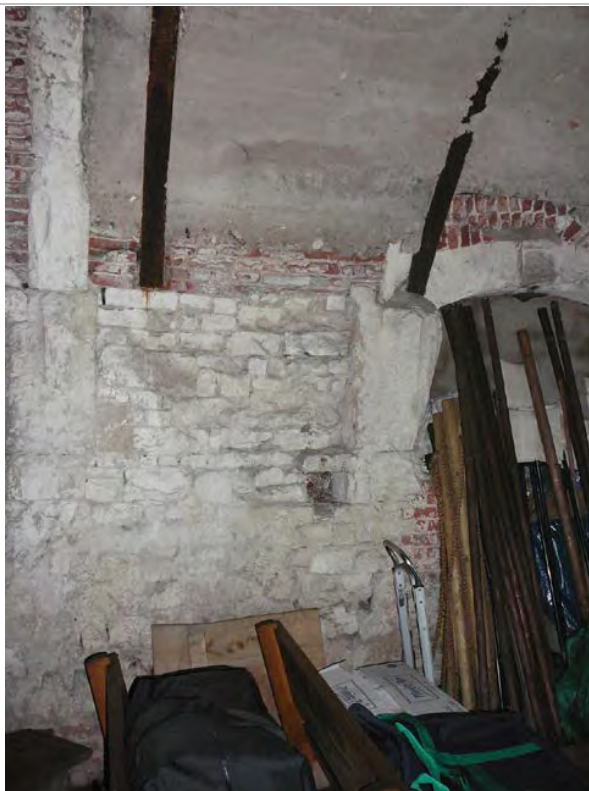
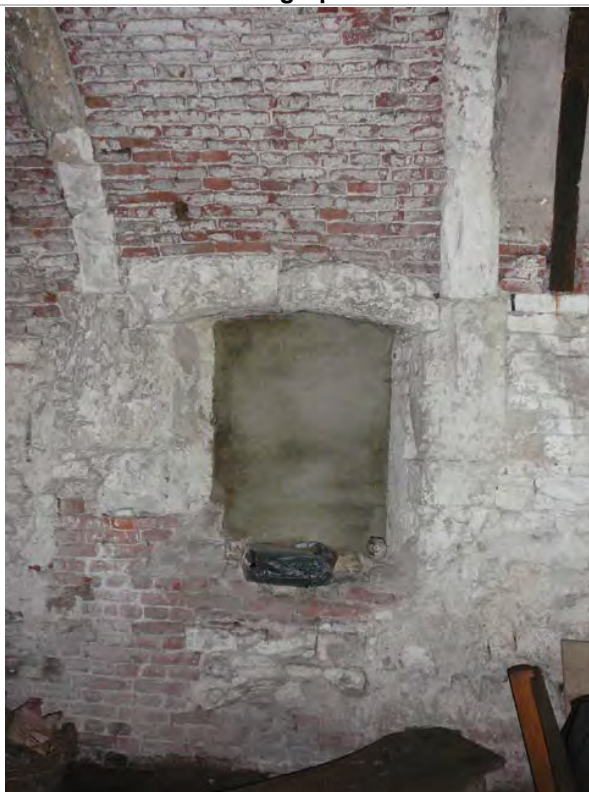
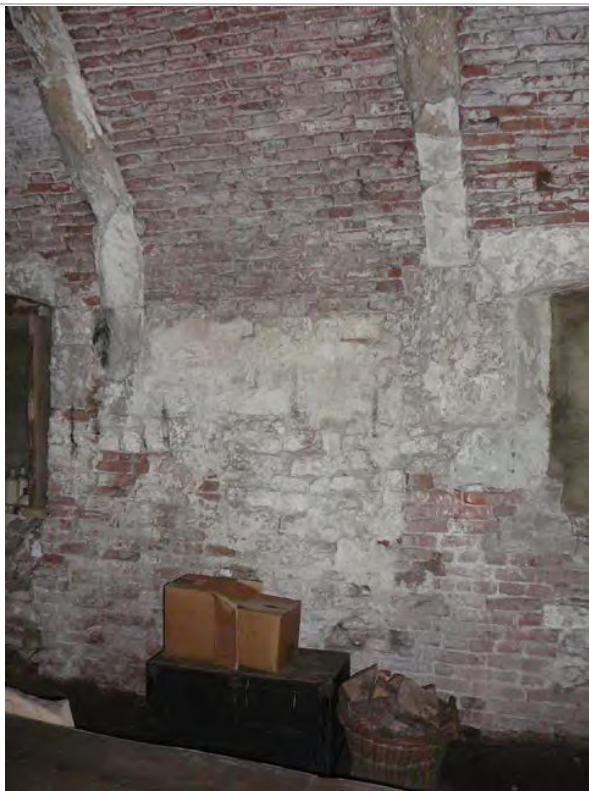
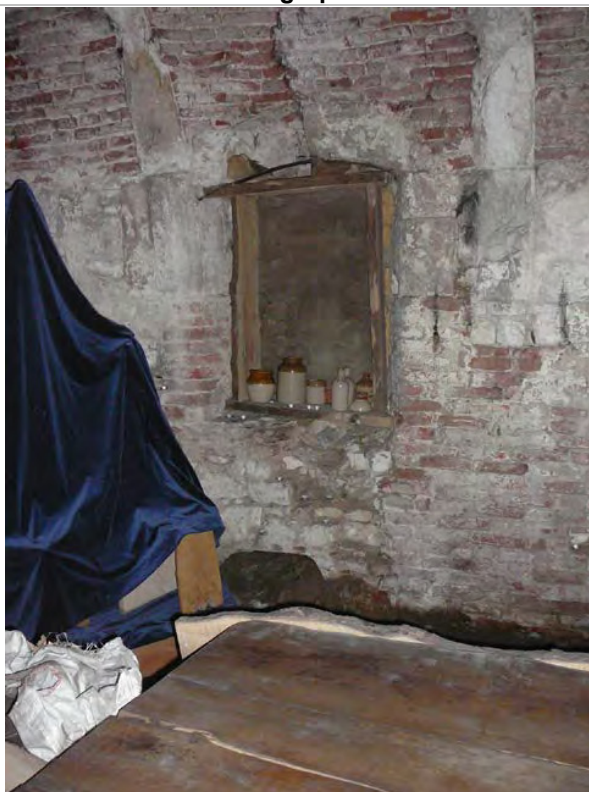
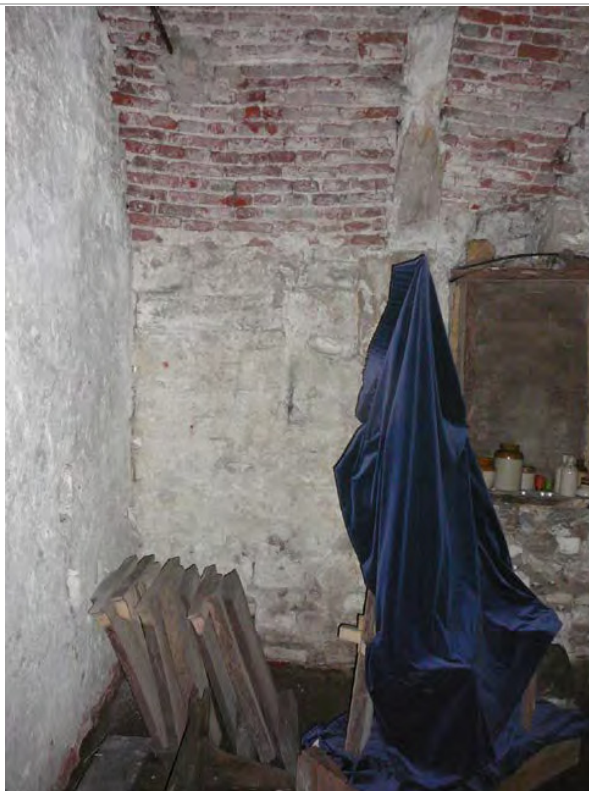
- 3.1.9 The north wall is in reasonable condition with one door opening in bay 1 and window openings in bays 3 and 5. All three chalk lintels have cracks or missing sections (photographs 24, 25, 26, 27, 28 & 29). The lintels should be pinned to reinstate their integrity.

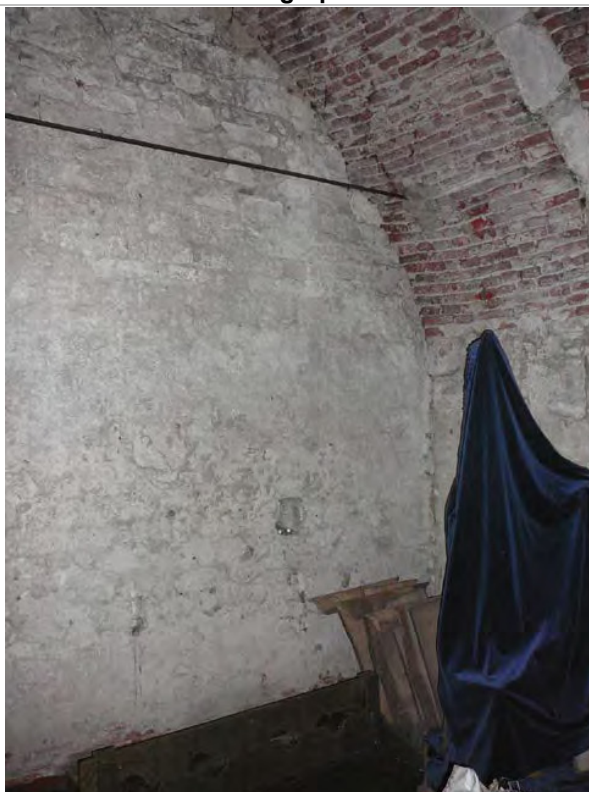
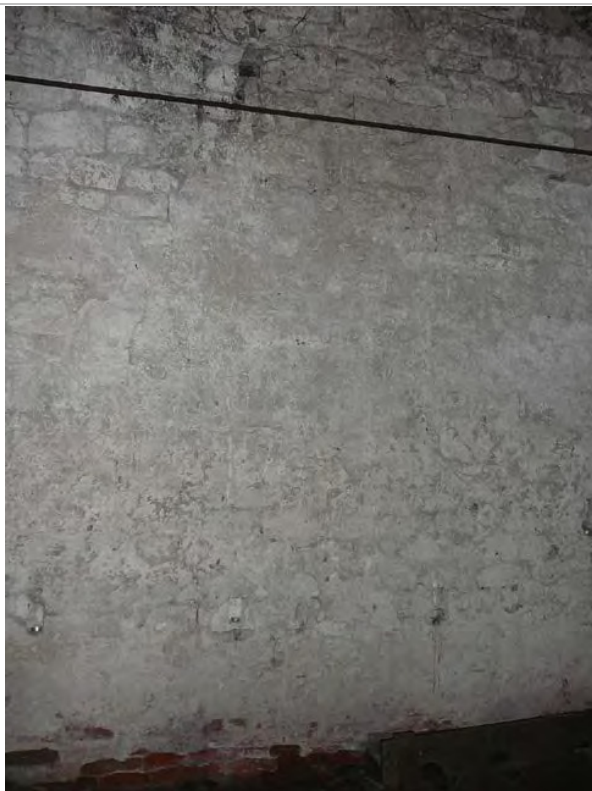
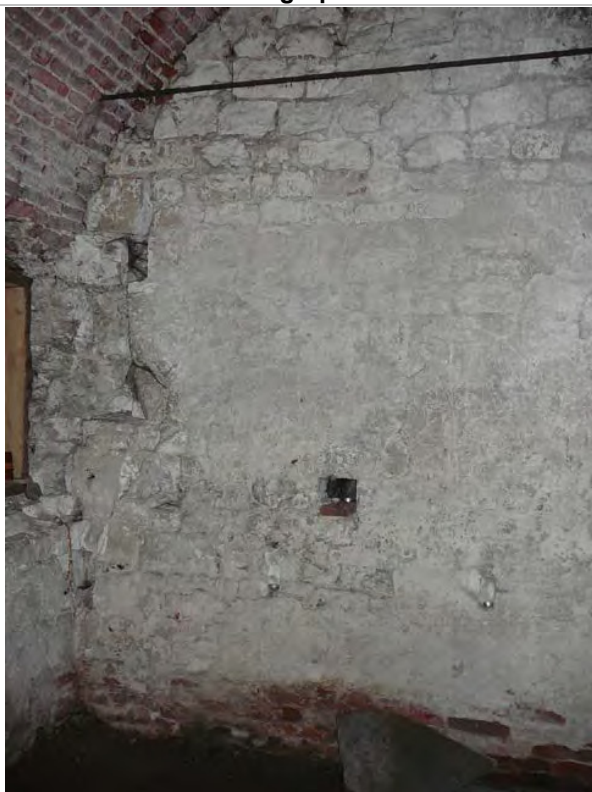
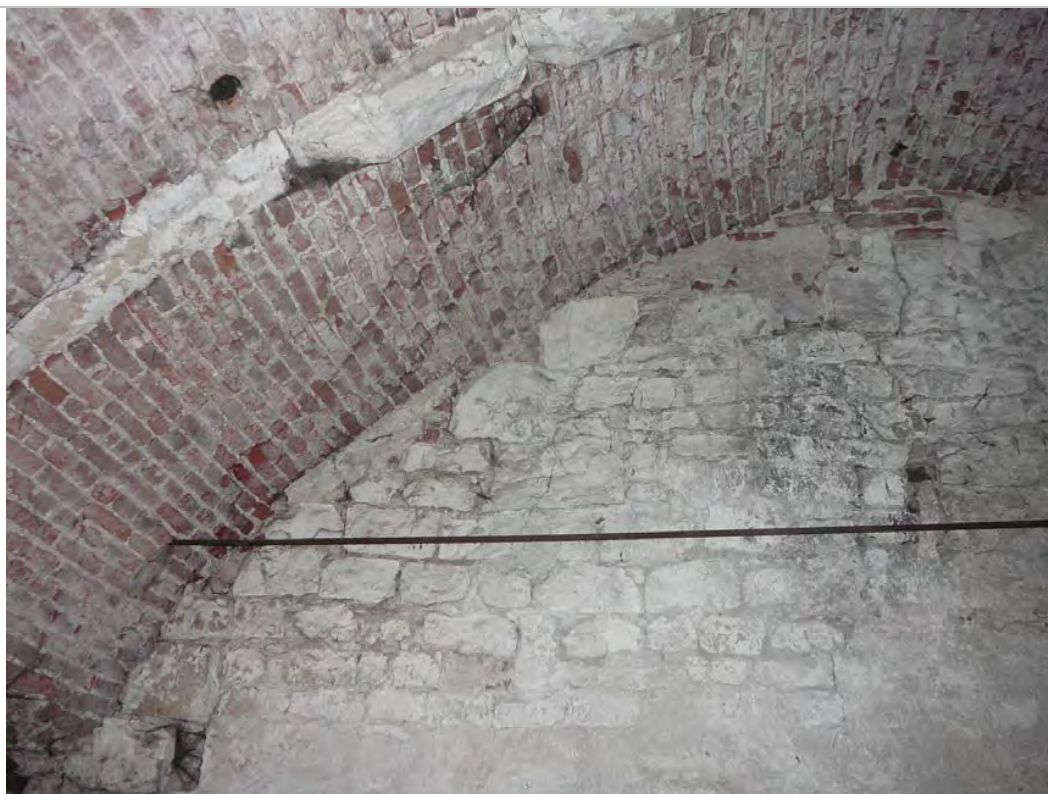
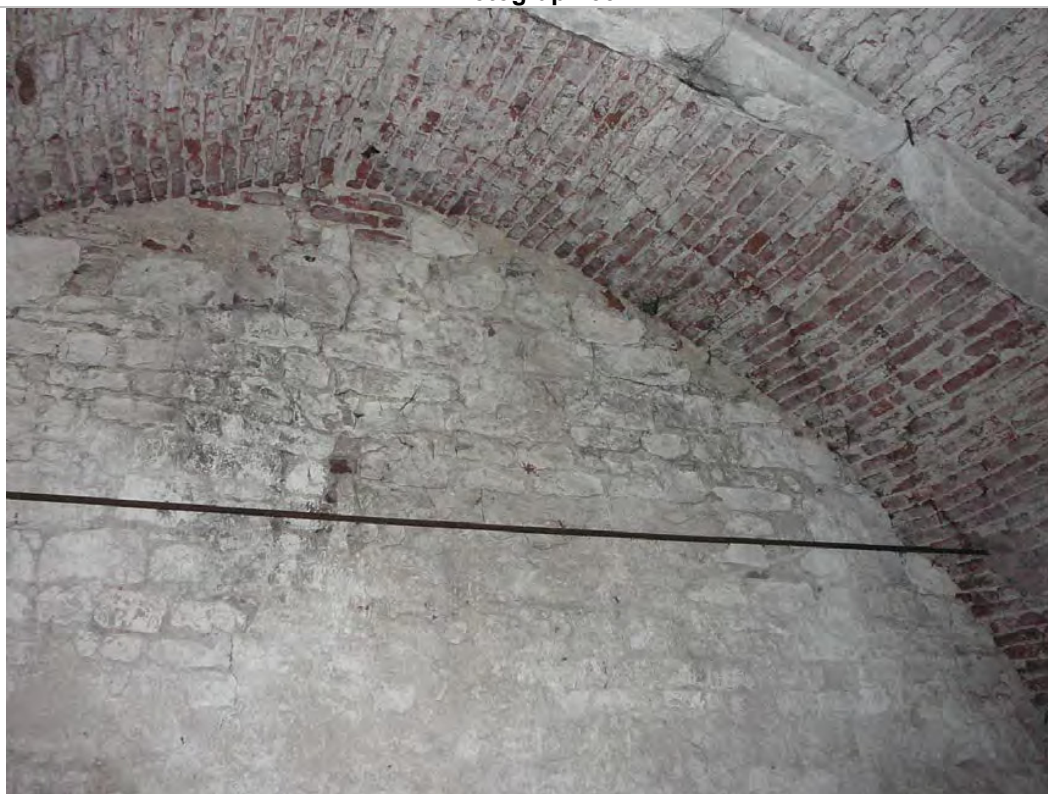
- 3.1.10 The west gable too appears to be in reasonable condition but with a vertical crack and voids at the southern corner (photographs 30, 31, 32, 33 & 34). The crack should be consolidated by polyester resin injection and the voids filled with small pieces of chalk and lime mortar.

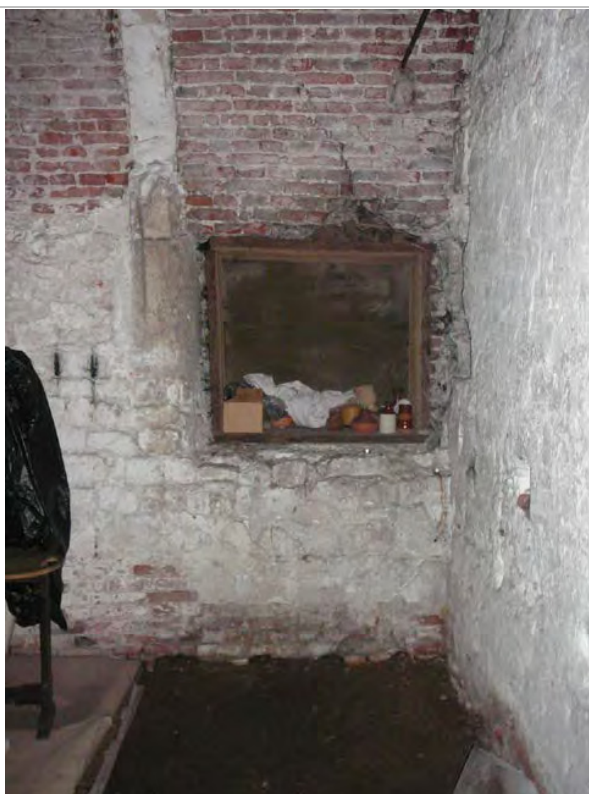
Photograph 35:

- 3.1.11 The south wall is in reasonable condition with a window opening in bay 6 which has no lintels (photographs 35, 36, 37, 38, 39 & 40). The window opening should be supported by oak lintels from short oak posts.

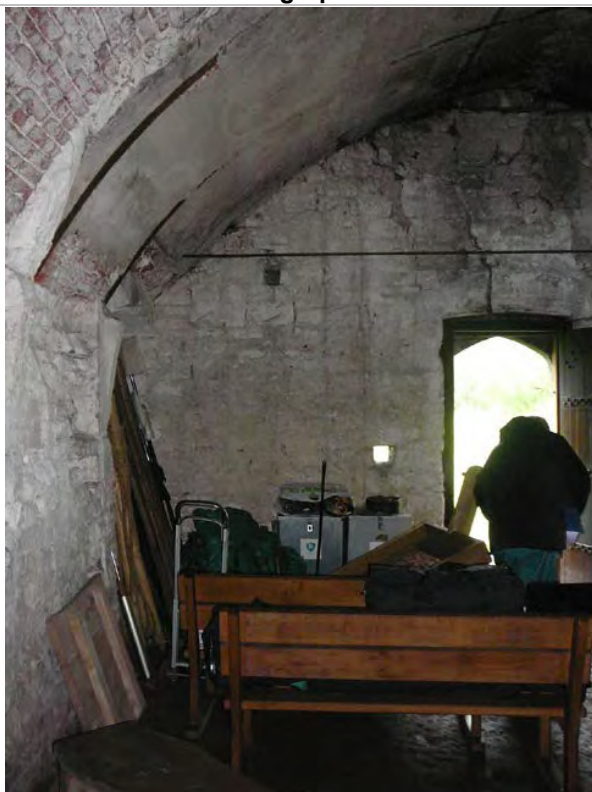
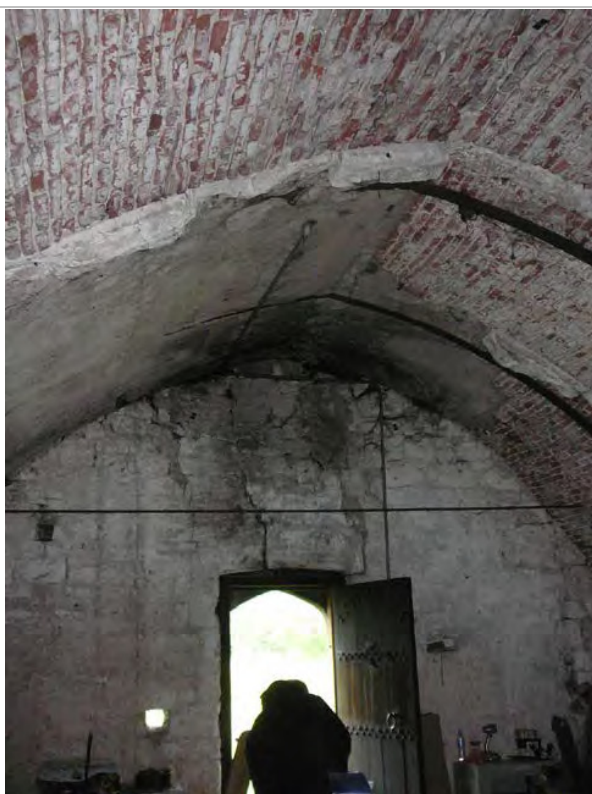
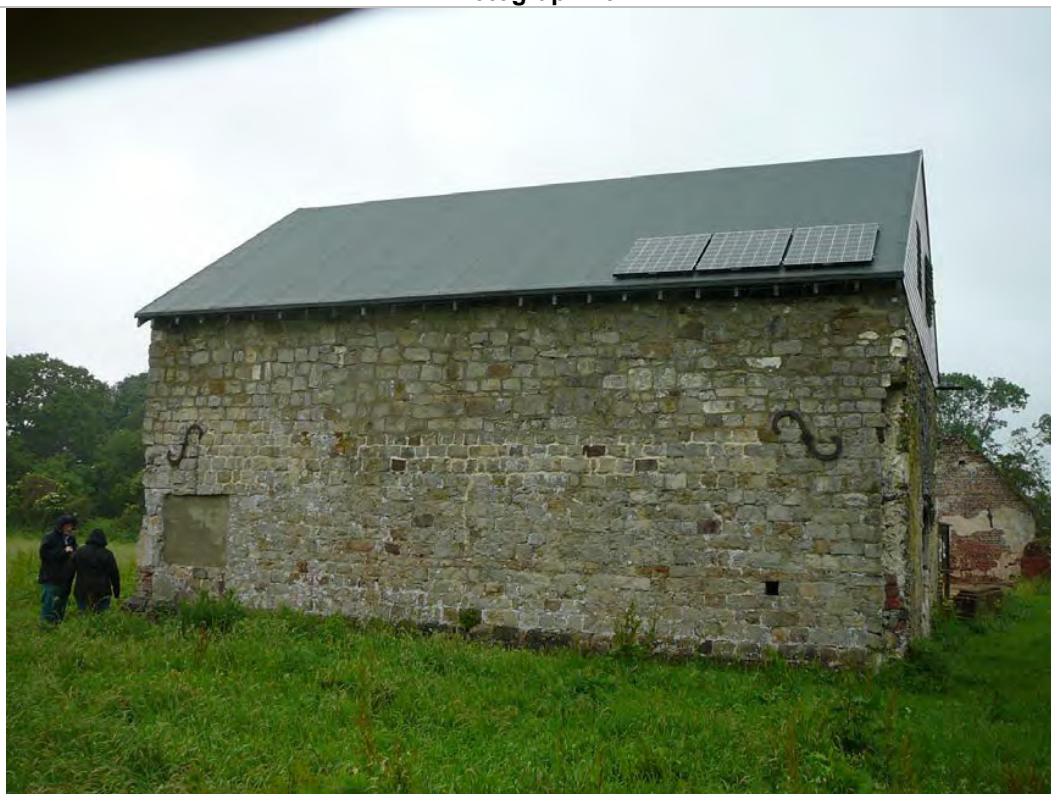
- 3.1.12 The east gable contains the doorway into the room. It too appears to be in reasonable condition. There is a vertical crack at the southern corner together with three previously repaired cracks above the door (photographs 41, 42 & 43). The vertical crack should be consolidated by polyester resin injection. The other cracks should be carefully raked out and also resin injected. A void at the end of the door lintel should be packed with slate.

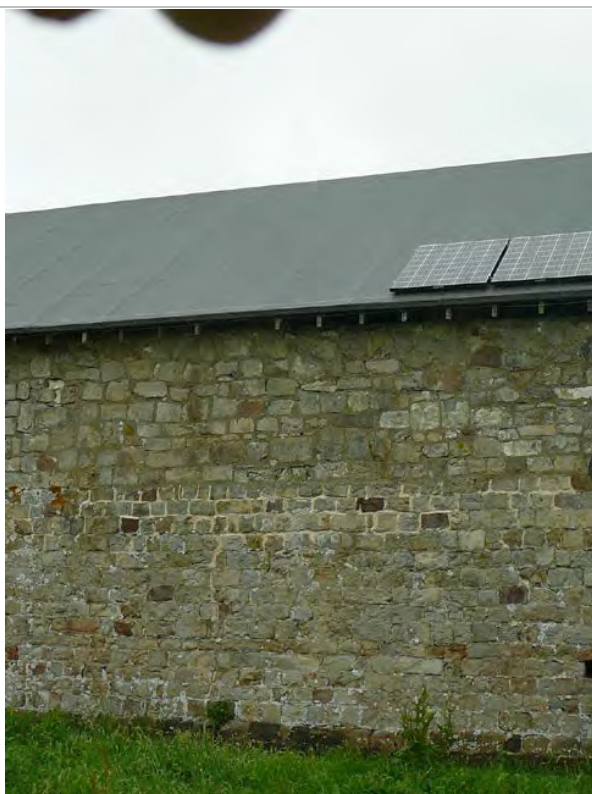
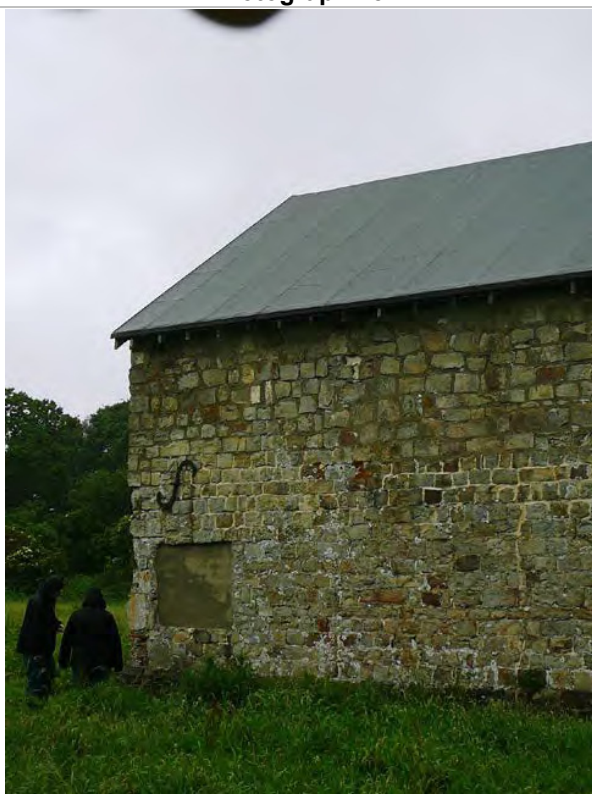
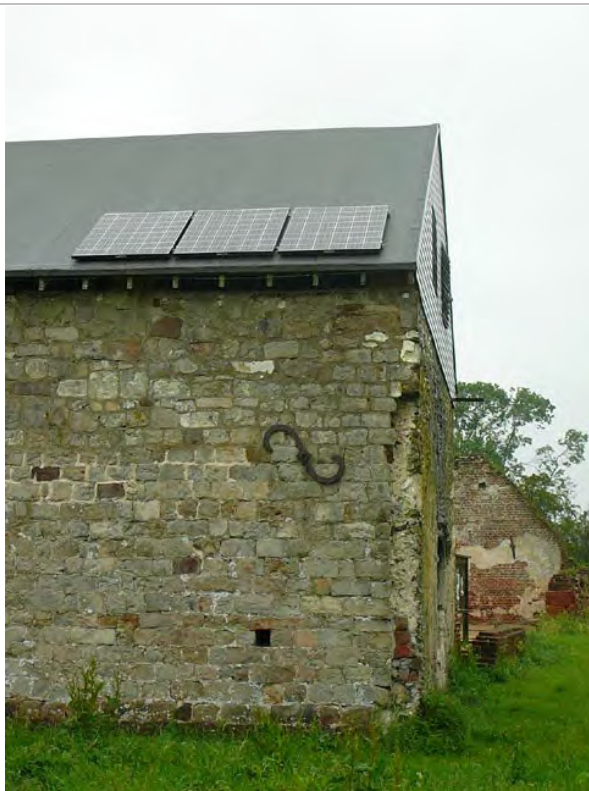
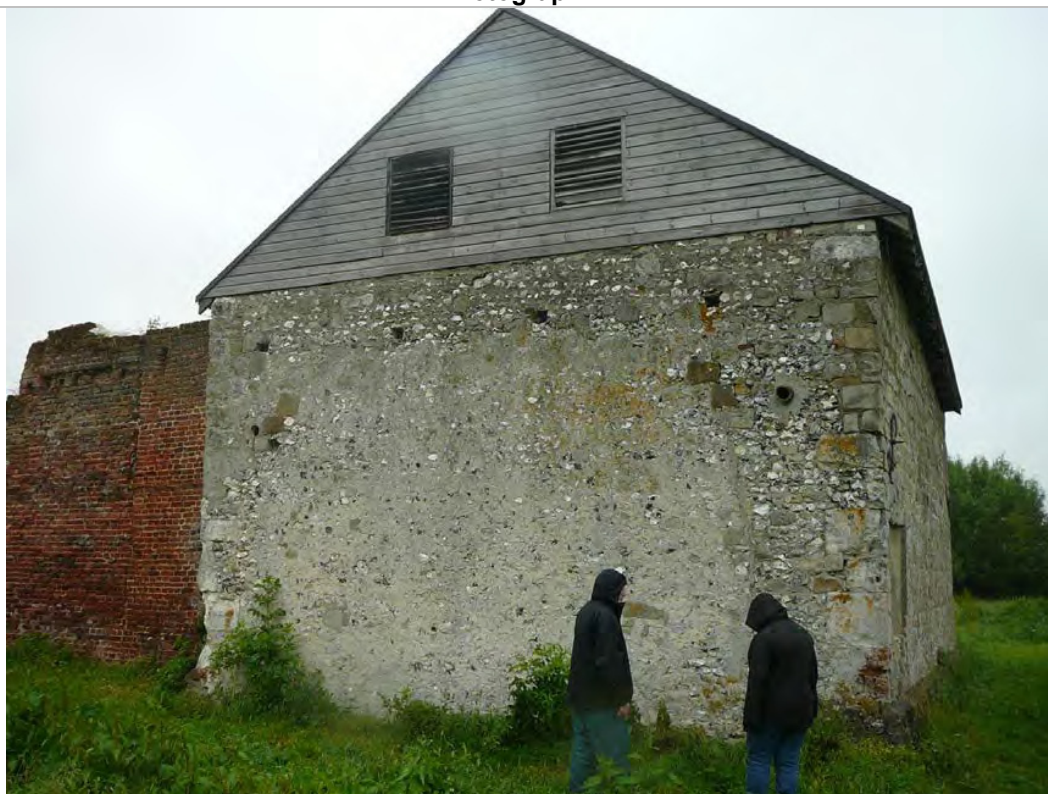
- 3.2.2 The south elevation is in reasonable condition. There is a previously repaired crack in the centre of the wall and a bulge around the middle third of its length. There are two S-shaped pattresse plates, one at each end, which are secure to the masonry. A window in bay 6 has been blocked up (photographs 44, 45 & 46). There is masonry missing from the south-east corner (photograph 47) and this should be replaced with bricks and lime mortar.

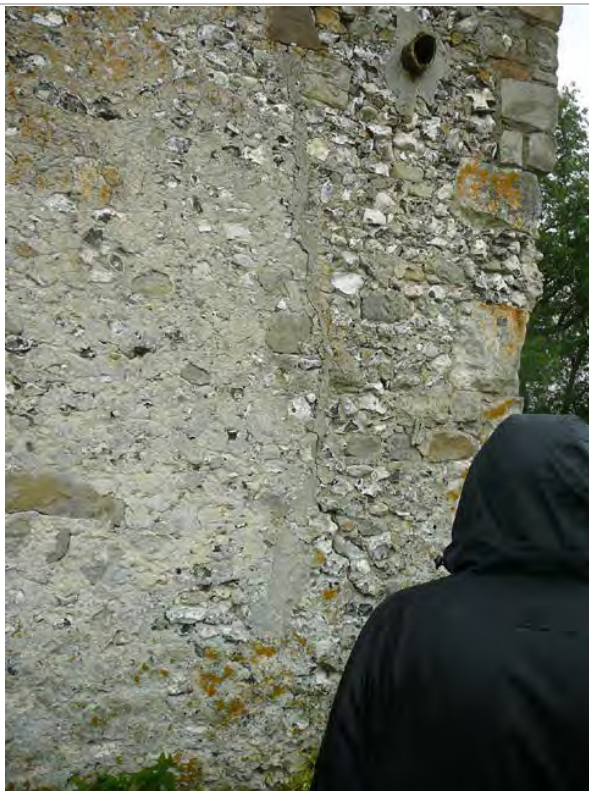
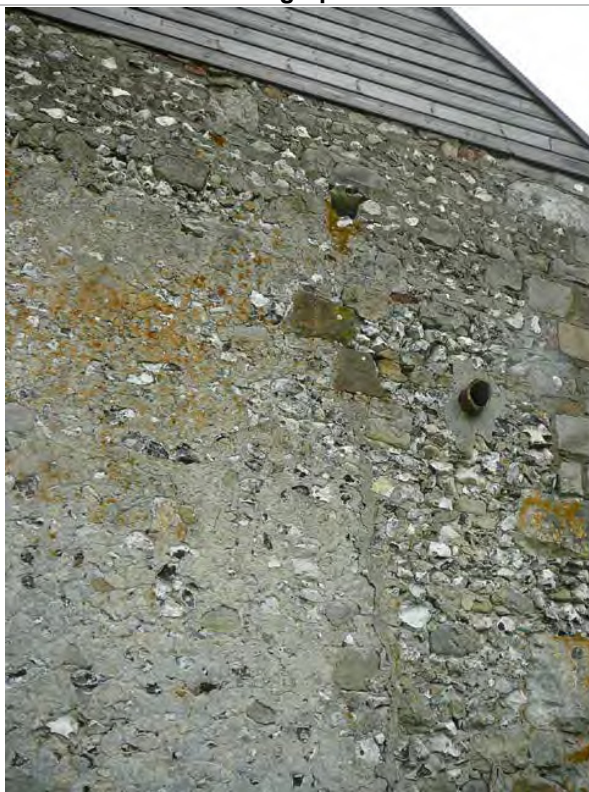
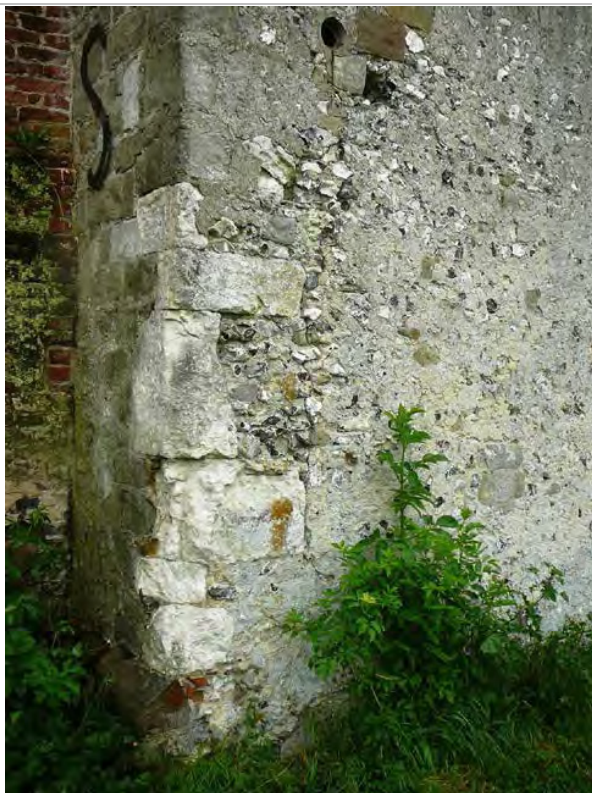
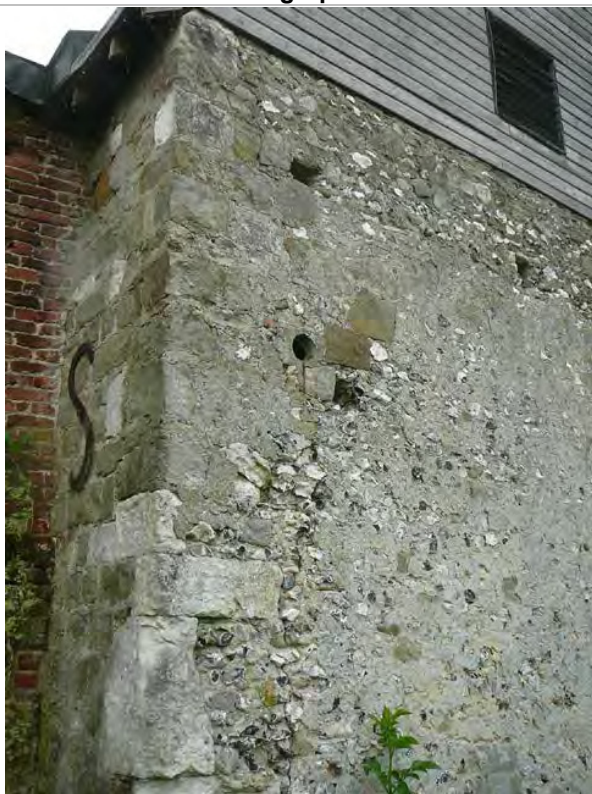
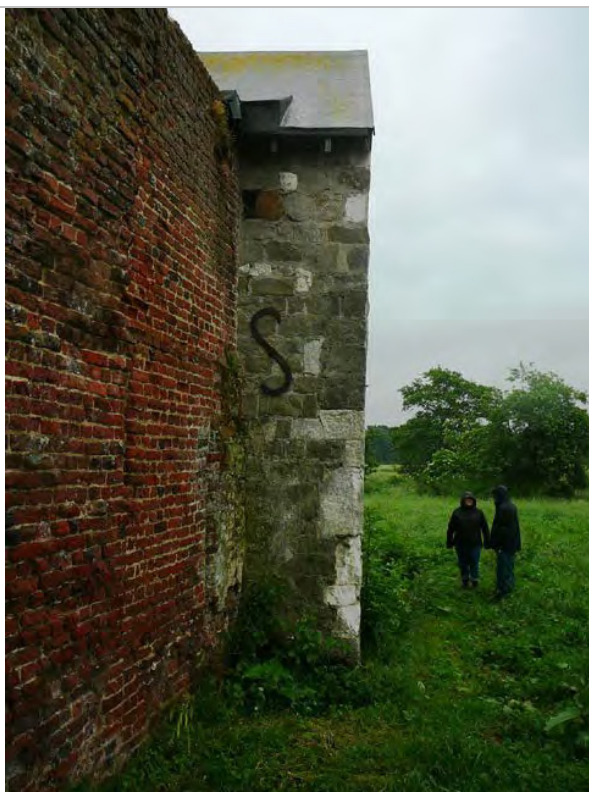
- 3.2.3 The west elevation too is in reasonable structural order. There is a previously filled nearly vertical crack at the southern end, (photographs 48, 49 & 50) together with a minor vertical crack between the quoins and the flint walling (photographs 51 & 52) which does not require attention.
