WOKING PALACE

CONSERVATION MANAGEMENT PLAN

CONDITION SURVEY

CONDITION REPORT (DRAFT)

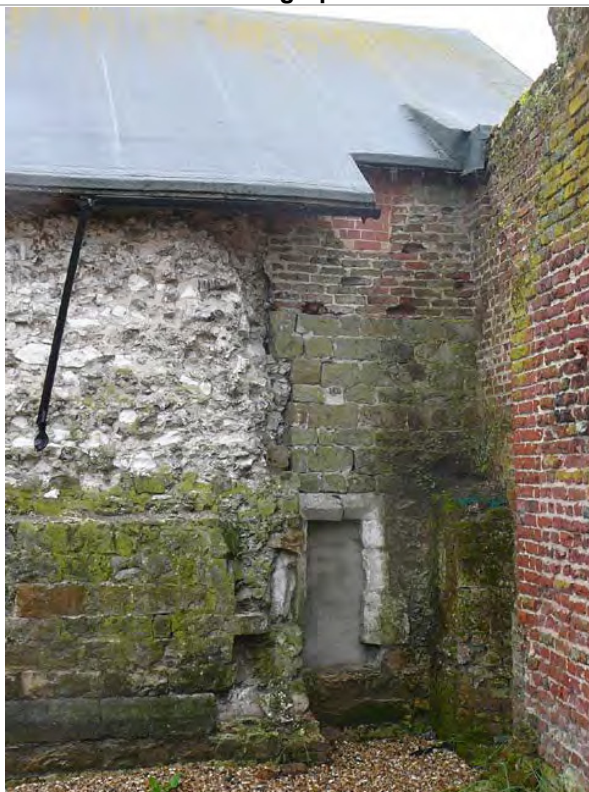
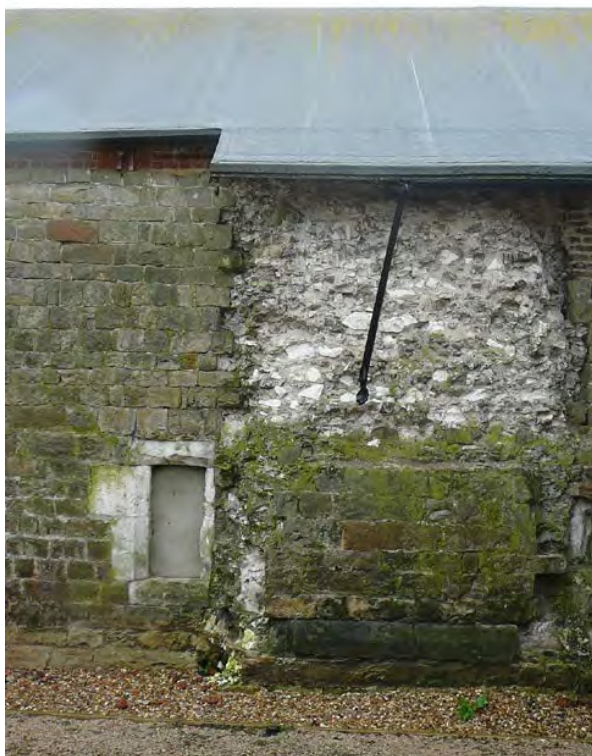
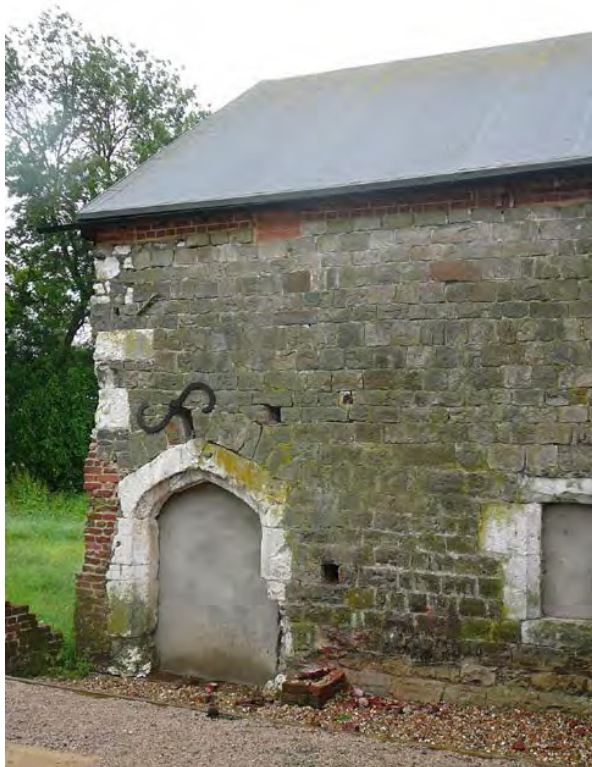
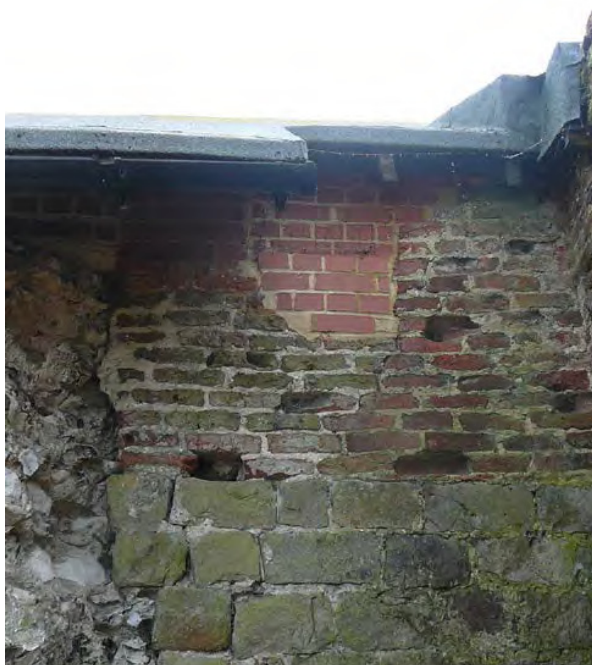
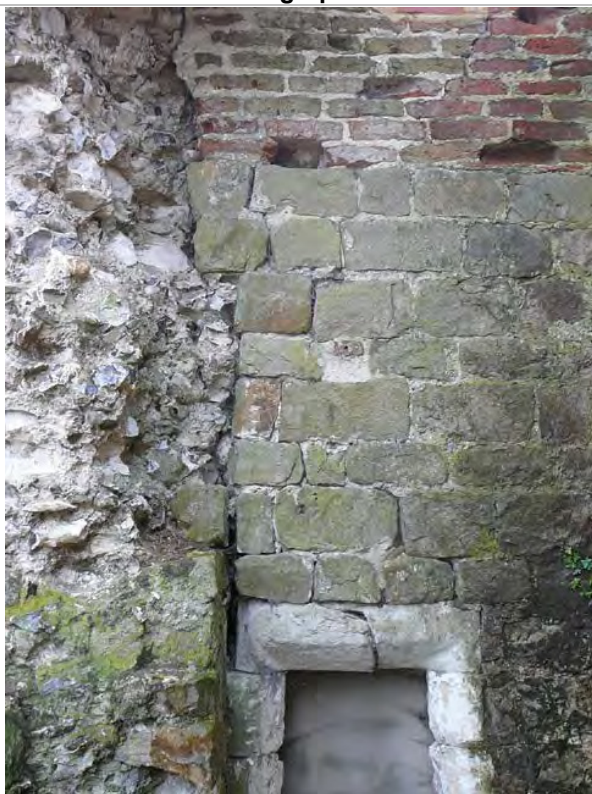
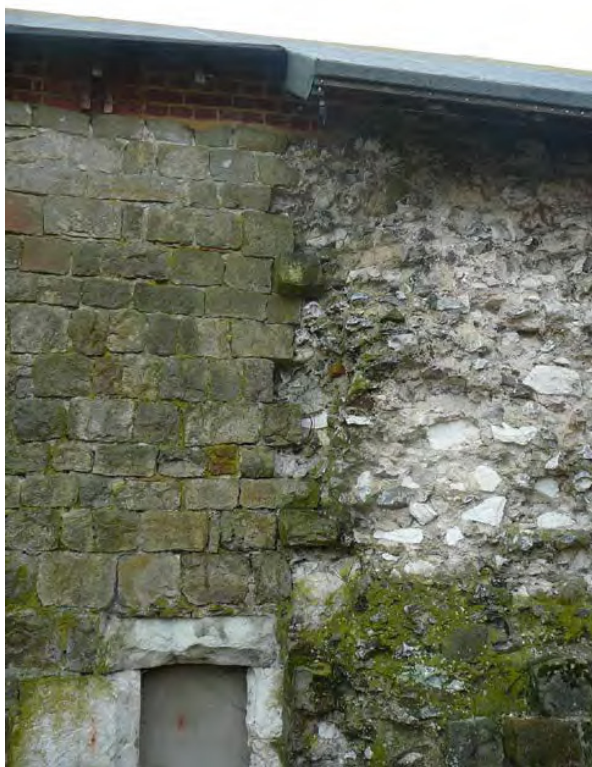
- 3.2.4 The north elevation is a mixture of construction by the insertion of a projecting chimney (photographs 53, 54, 55 & 56). Either side of the chimney are windows, whilst at the east end there is a doorway. Two S-shaped pattresse plates are visible, which match the two on the south elevation. To the right of the chimney at high level, there is a new panel of brickwork. Below this there is a diagonal crack which runs through the blocks of stone, down the joint with the chimney and finishes with the cracked window lintel (photographs 57 & 58). The crack should be injected with polyester resin and the lintel pinned together.

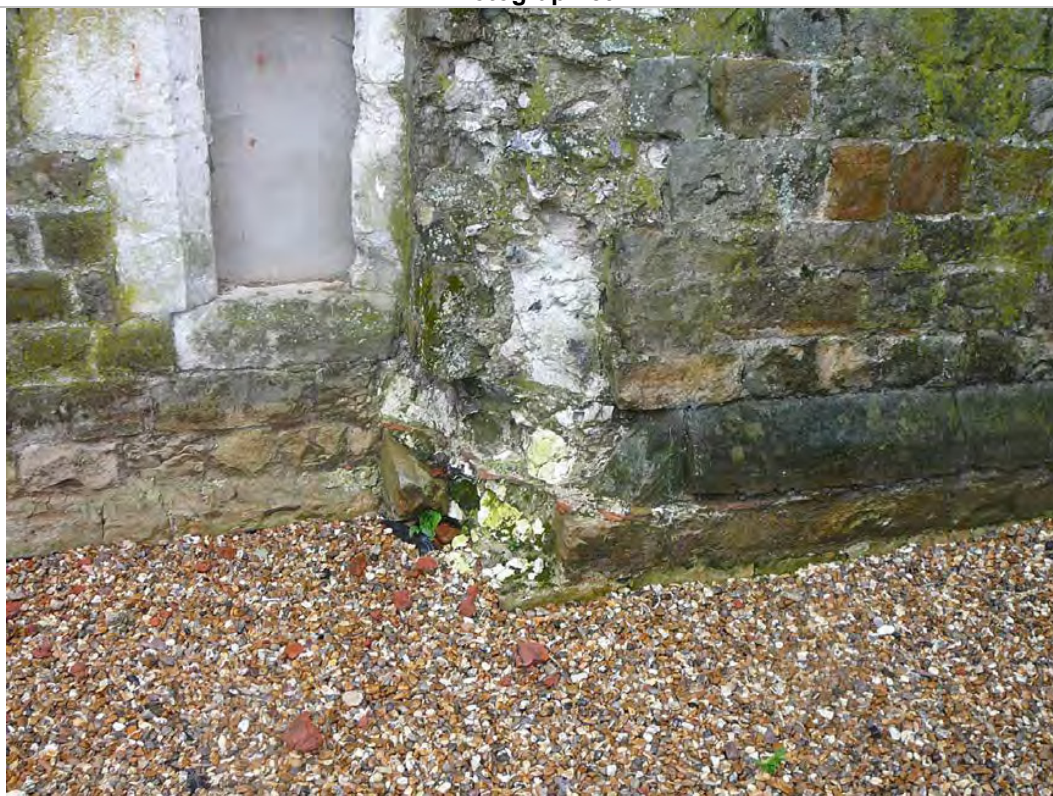
Photograph 59:

- 3.2.5 There is a similar discontinuity down the left hand side of the chimney (photograph 59) but it is considered that this does not require any attention.

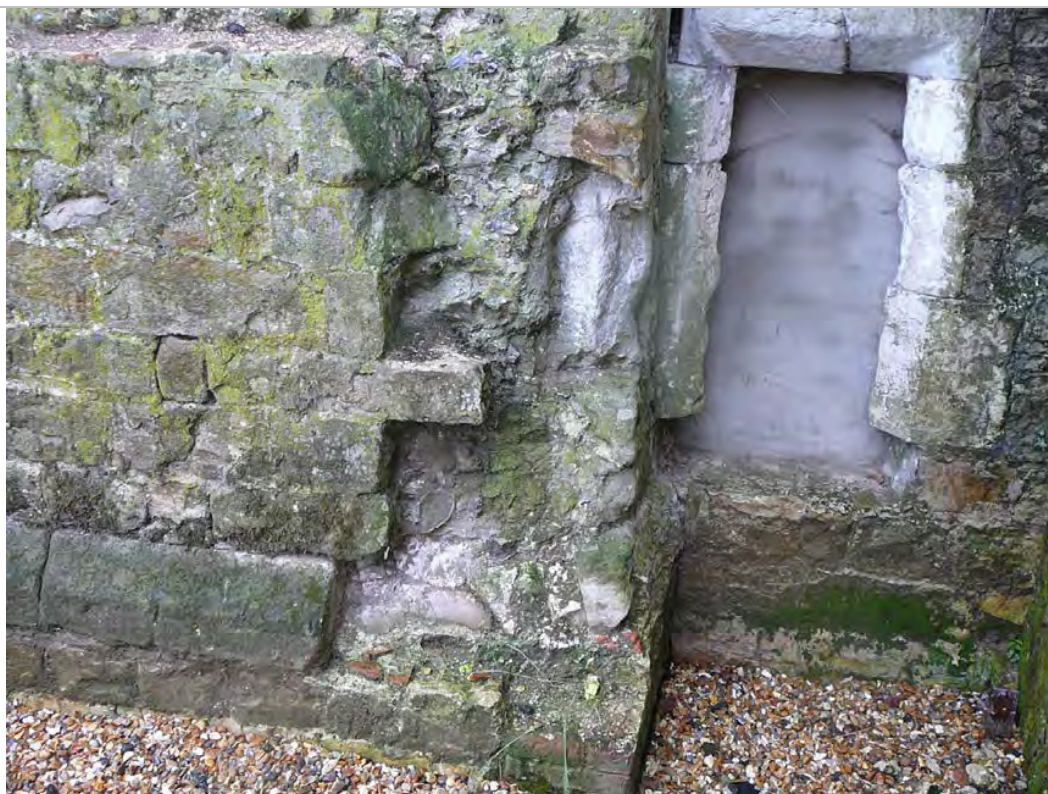
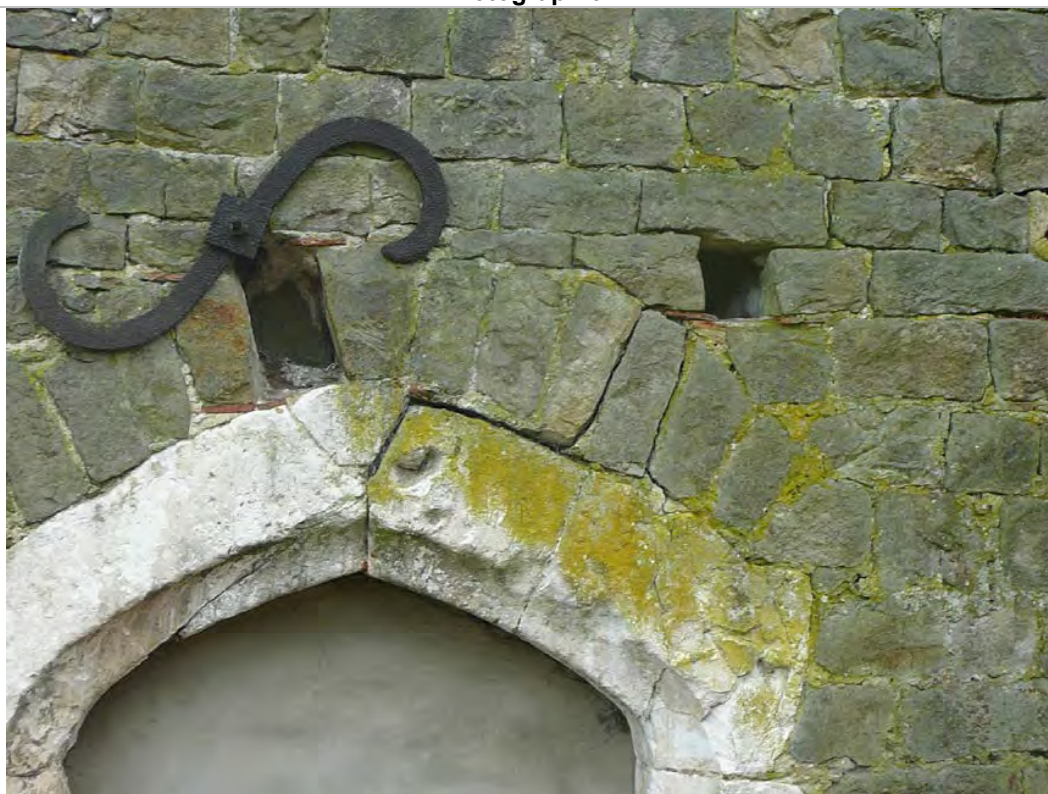
- 3.2.6 The base of the chimney is eroded (photographs 60 & 61) and these should be built back in suitable masonry.

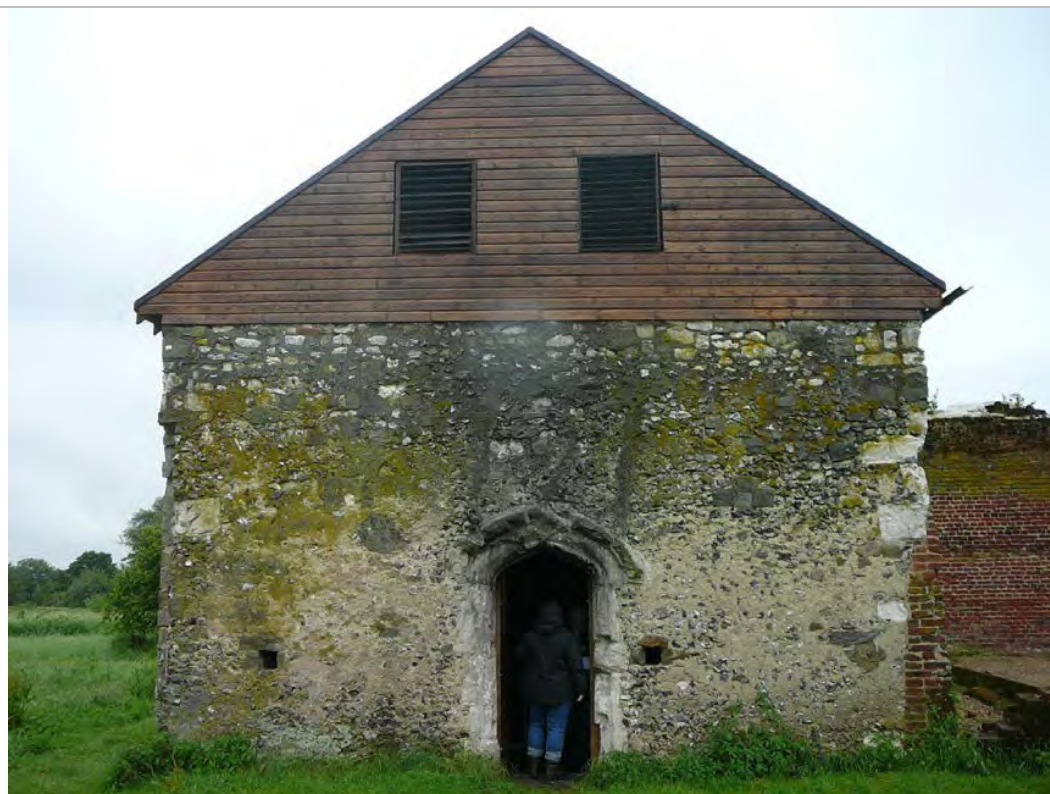
Photograph 62:

3.2.7 The arched doorhead has dropped and there is a missing stone from the relieving arch above the doorhead (photograph 62). The missing stone of the relieving arch should be replaced and the chalk doorhead pinned back together.

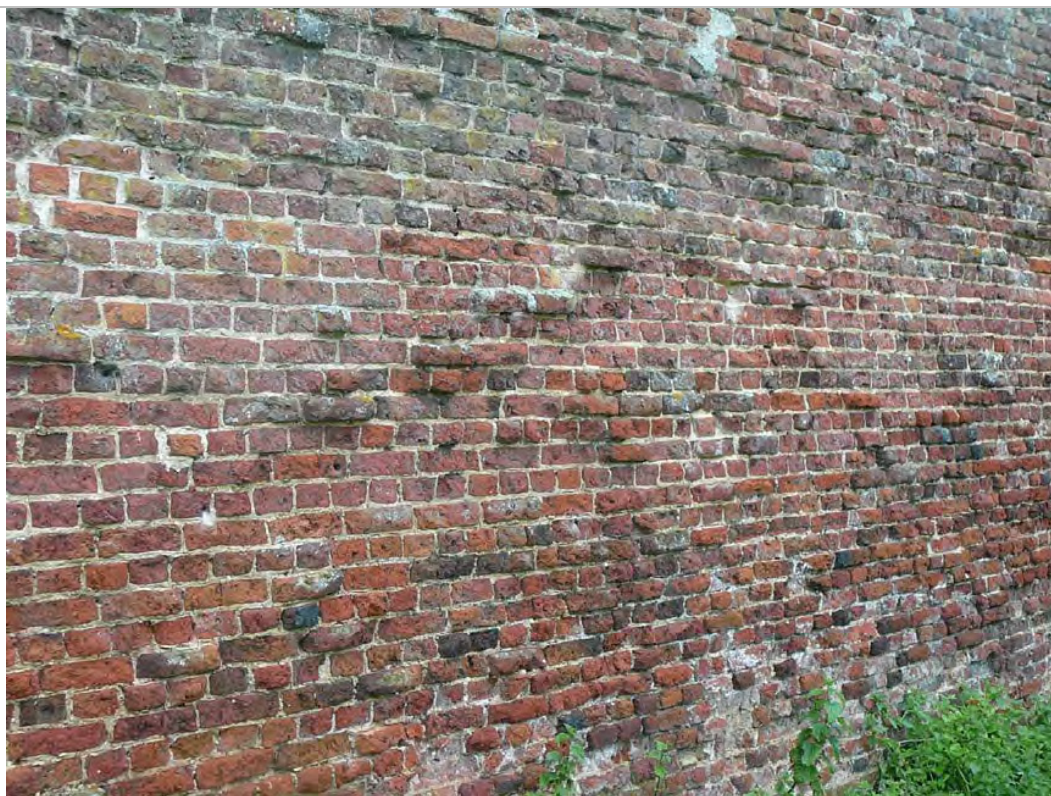
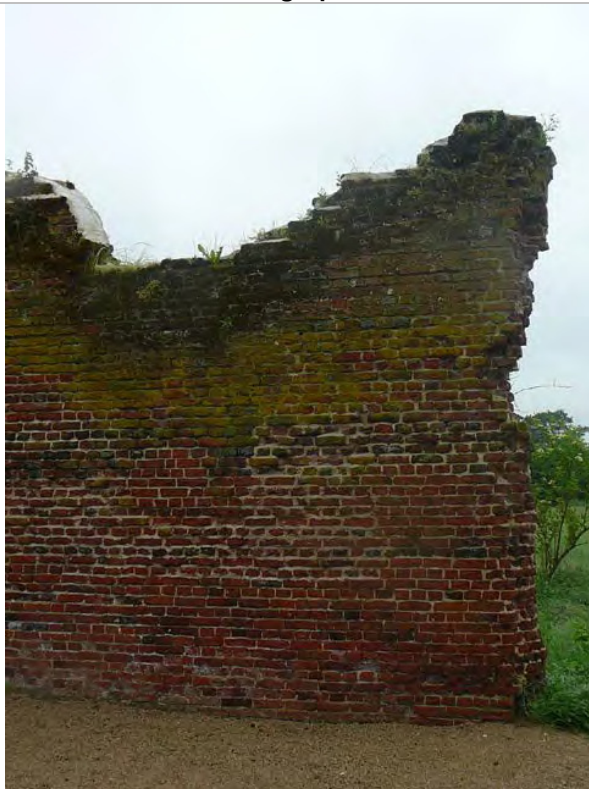
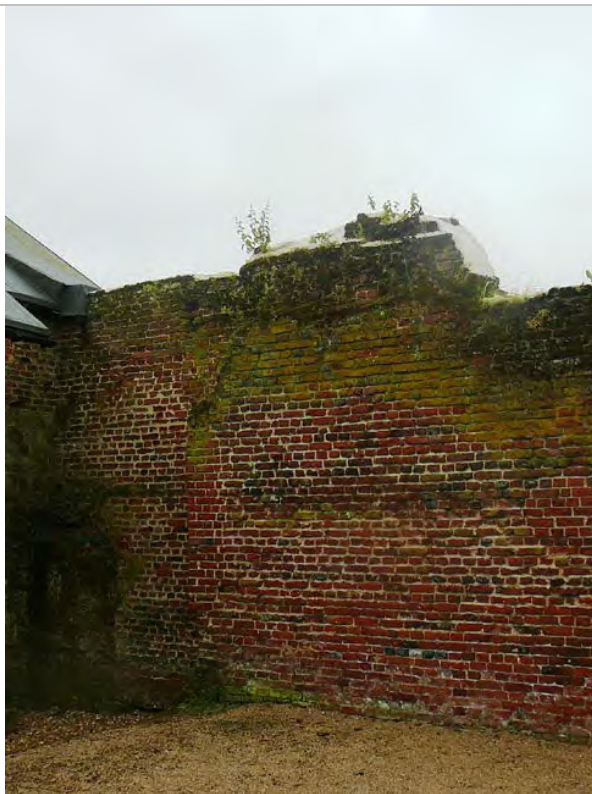
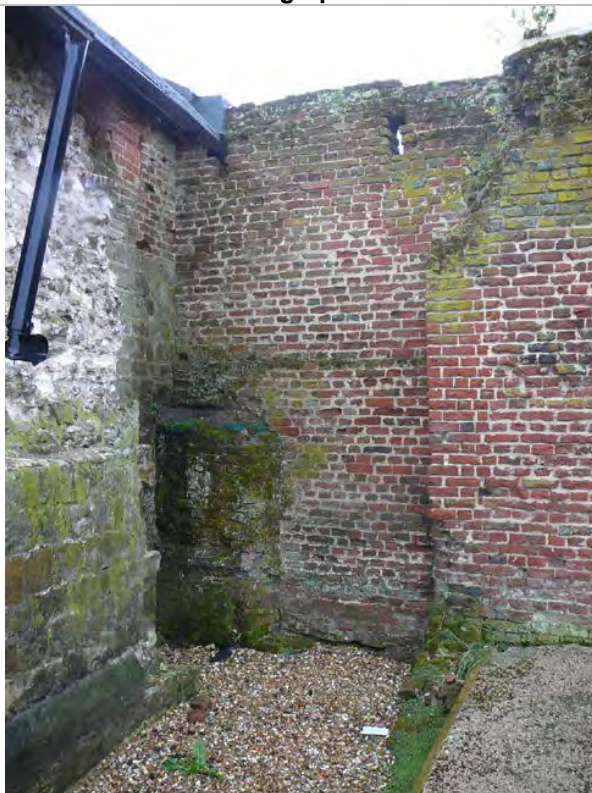
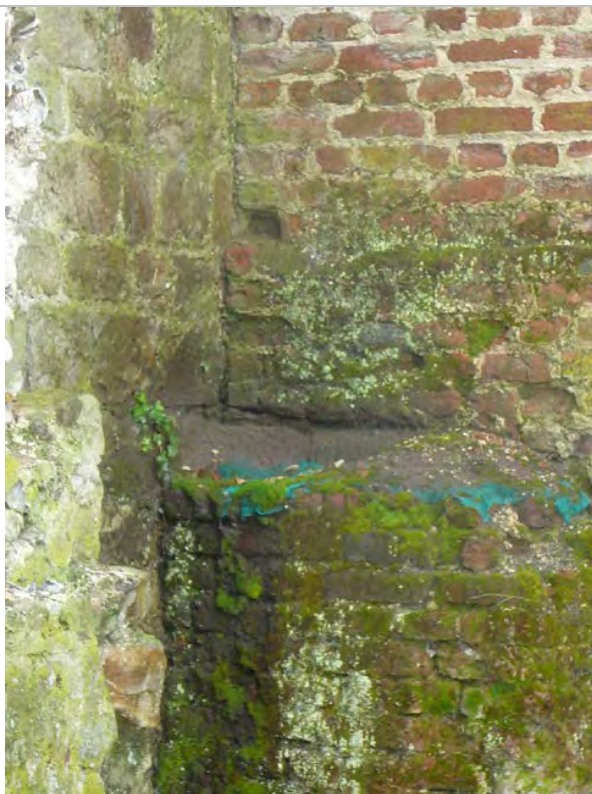
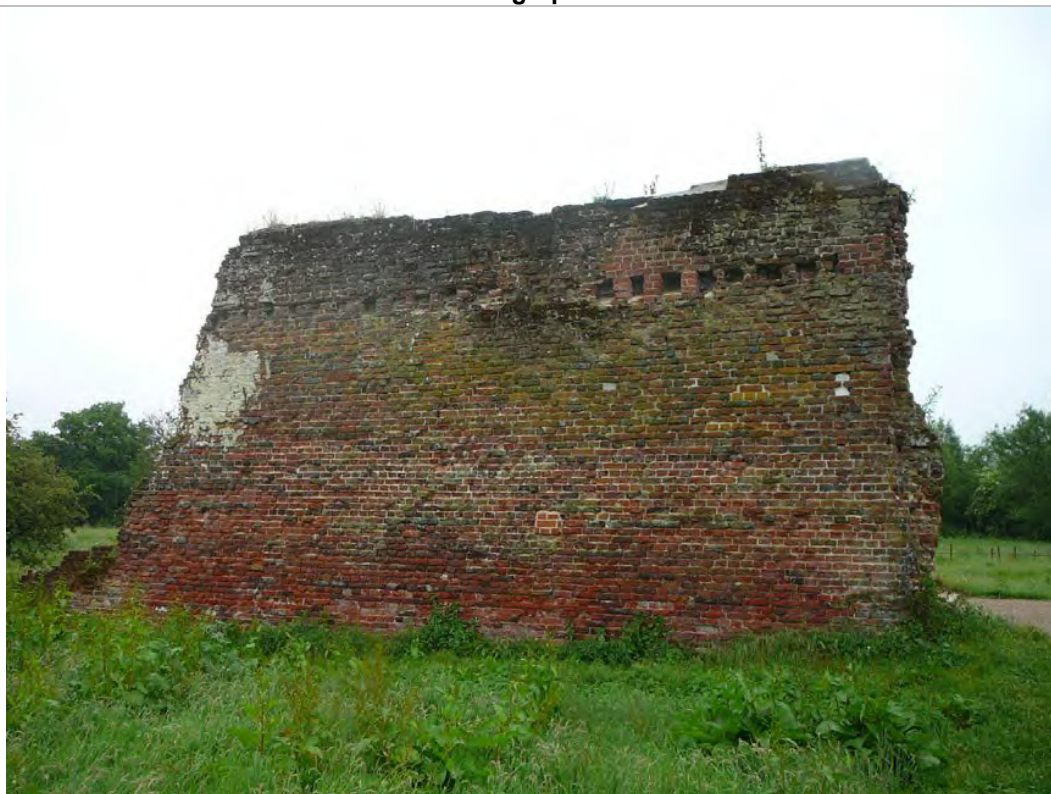
3.3.2 The western face of the southern section of the west wall is eroded in places but nevertheless structurally sound due to its robust thickness (photographs 64 & 65). The eastern face too appears to be in sound structural order (photographs 66 & 67) but water discharge from the roof of the vaulted undercroft has allowed a massive algal growth and caused some erosion of bricks at the junction between the two walls (photographs 68 & 69). If this is allowed to continue, frost will create further damage. No structural repairs are envisaged.

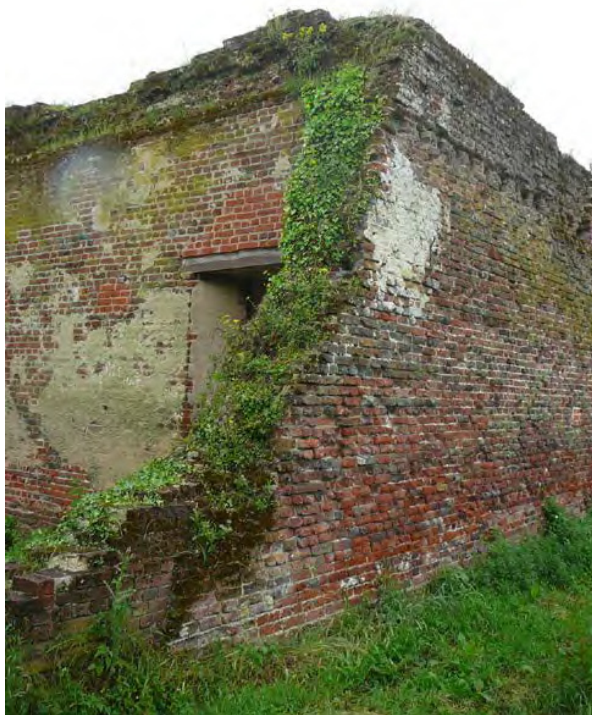
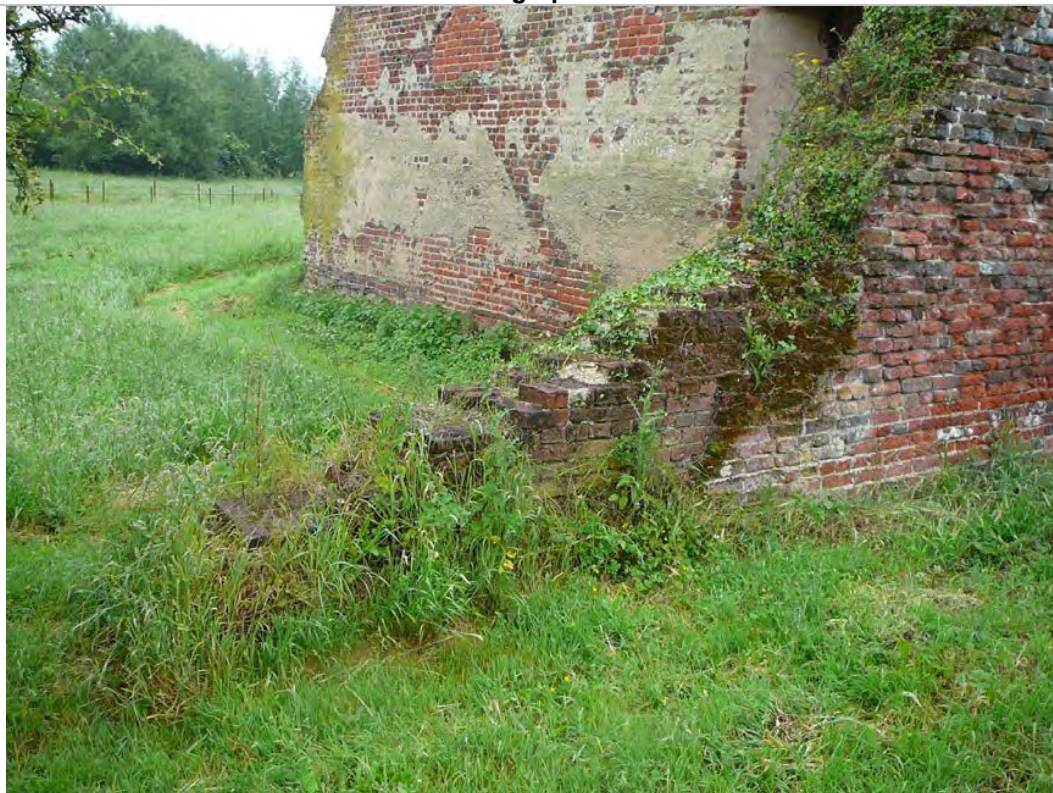
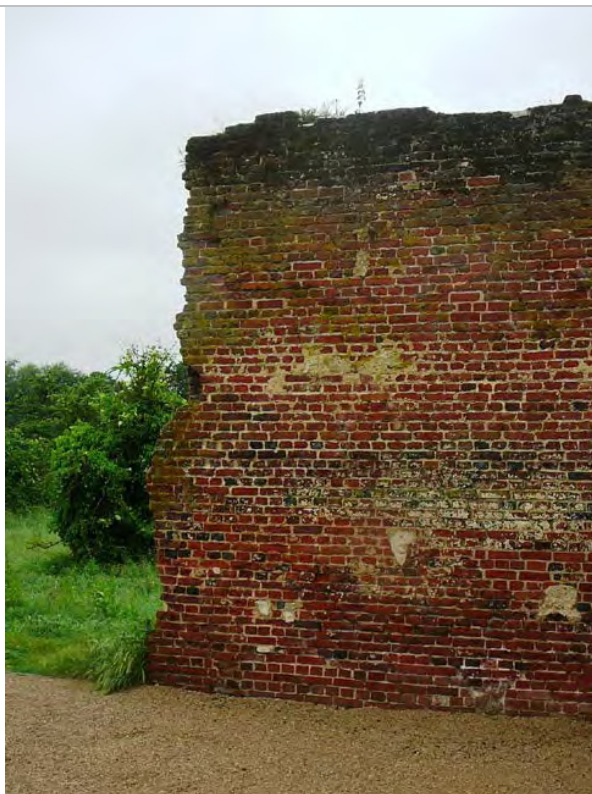
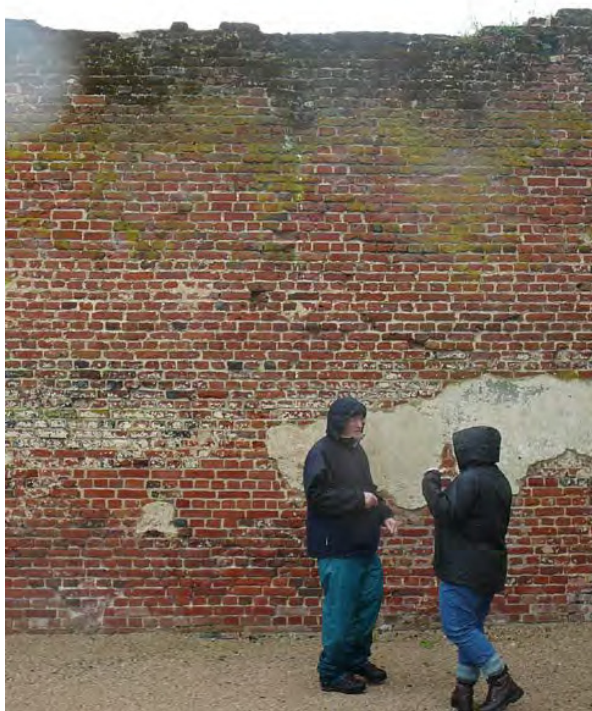
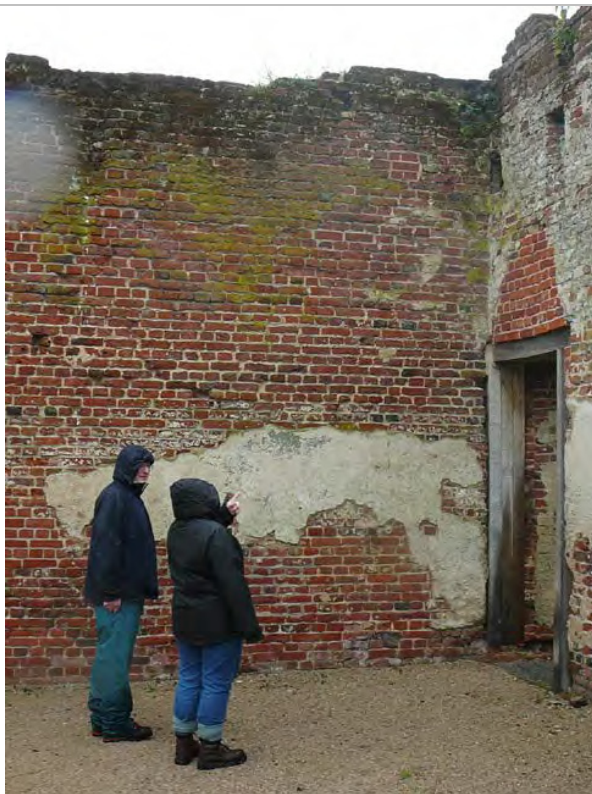
3.3.3 The western face of the northern section of the west wall is eroded in places but nevertheless structurally sound due to its robust thickness (photographs 70, 71 & 72). The north end of the wall tapers away to ground level and is covered by vegetation. Protection should be considered to prevent water ingress into the exposed masonry beds. The eastern face too appears to be in sound structural order (photographs 73, 74, 75 & 76). No structural repairs are envisaged.

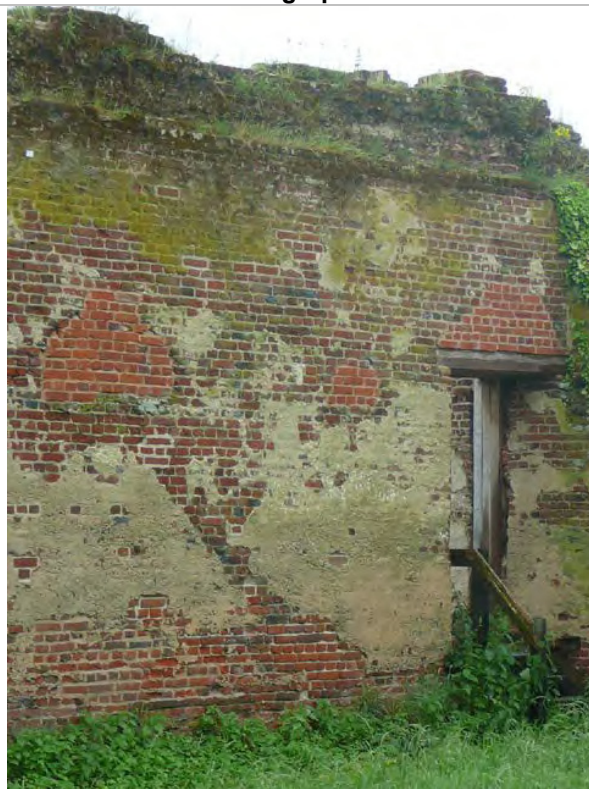
Photograph 77:

3.3.4 The north face of the north wall is in sound structural condition (photographs 77, 78, 79 & 80). There are several areas of patched repairs but no structural repairs are envisaged. The doorway at the west end has been repaired with oak lintels. The south face of the north wall is also in sound structural condition (photographs 81, 82 & 83) and again no structural repairs are envisaged. The eastern end of the wall slopes down and both this end and the top of the wall would benefit from protection to prevent water ingress into mortar beds.

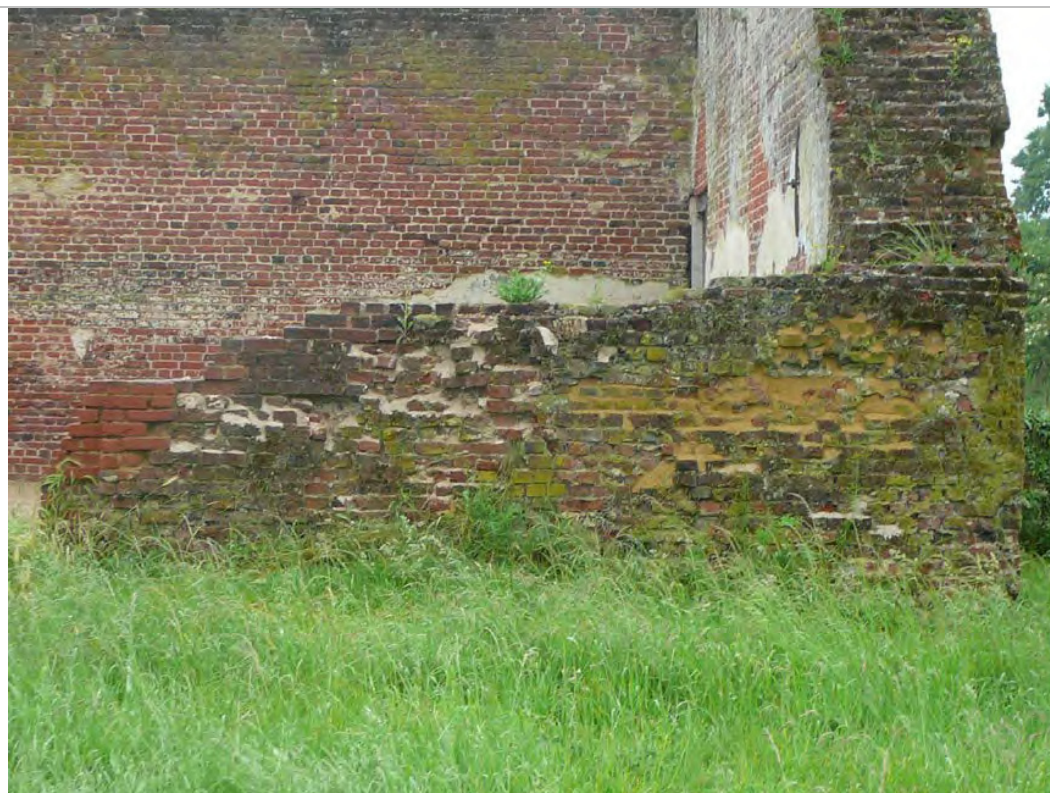
Photograph 84:

3.3.5 The east wall is low level. There is erosion of brickwork on the eastern face and evidence of repairs to the south end, (photographs 84, 85 & 86). Here again no structural repairs are envisaged but the top of the wall would benefit from protection to prevent water ingress into mortar beds.

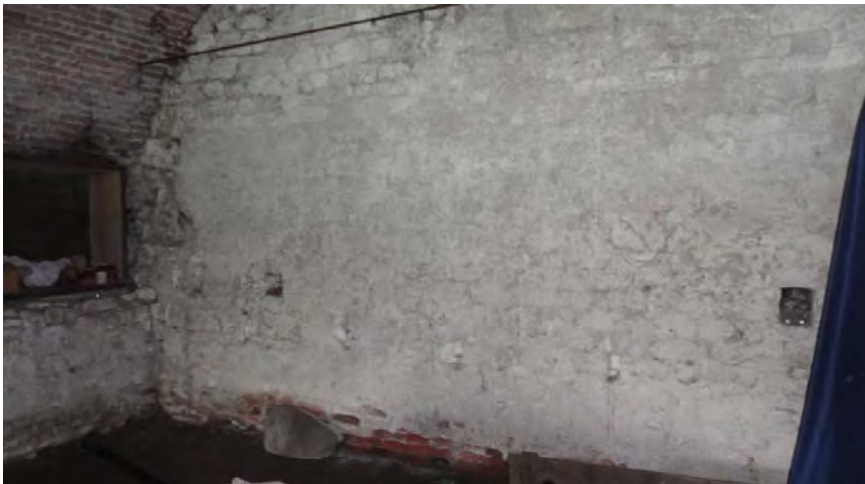
Figure 6. Lime Slurry coat and brick plinth to West Gable.

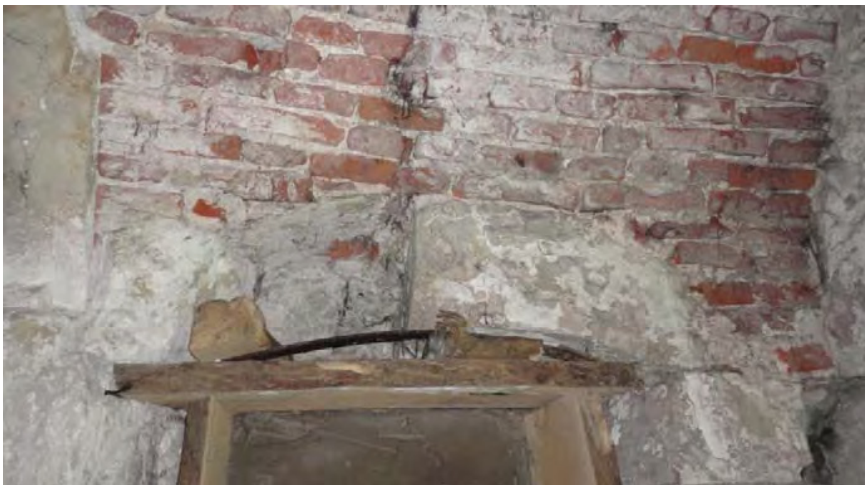
Figure 7. Iron bar supporting remaining half of chalk lintel to window in north wall of bay 5.

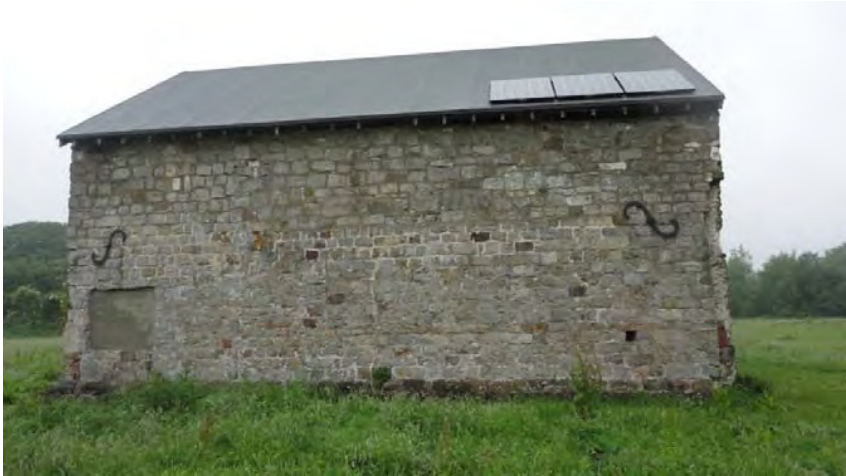
Figure 12. South Elevation of Vaulted Chamber showing photo voltaic cells on felted roof and 1920's window insertion without lintel.

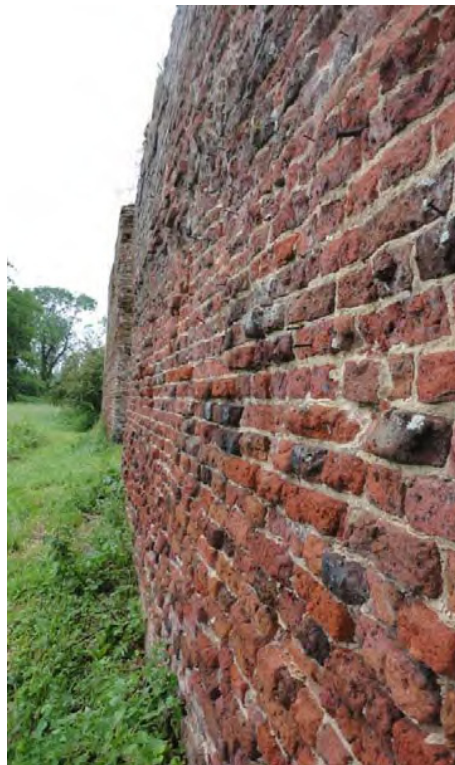
Figure 18. West face of brick wall of Service Building (former external elevation) showing extent of erosion to brick.

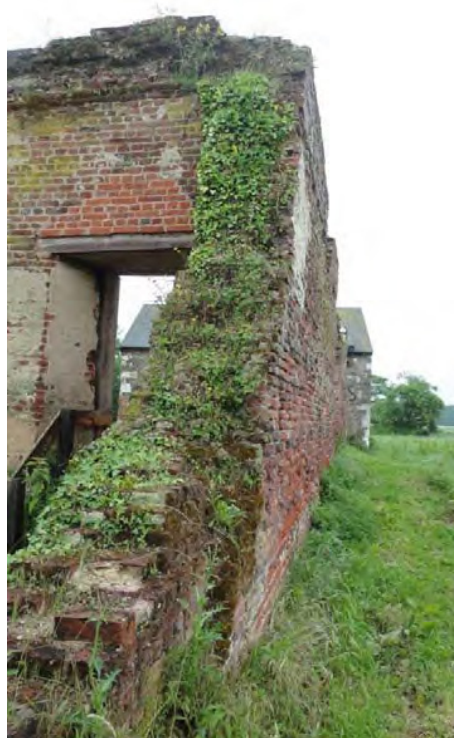
Figure 19. Consolidated wall end to West Wall of Service Building showing ivy growth which should be removed. Also recently installed timber lintels and steps to door opening.

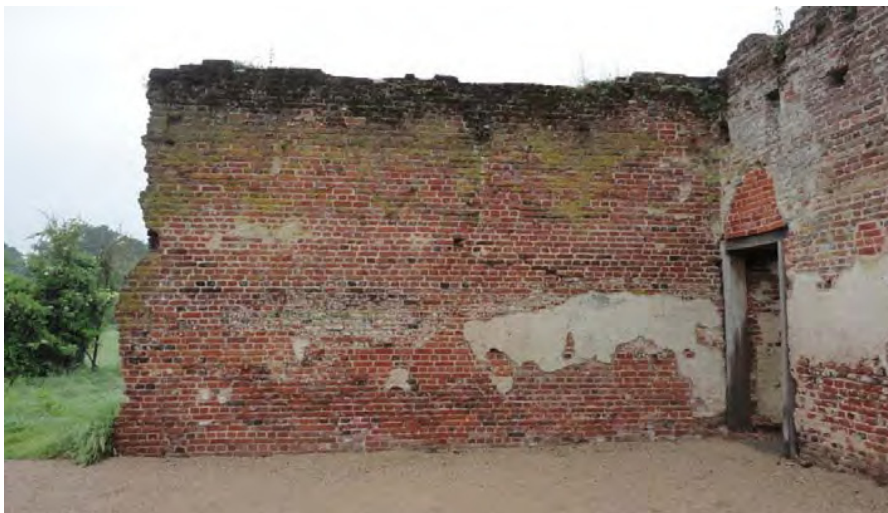
Figure 20. Norther Section East Face of Service Building West Wall showing remnants of lime plaster.

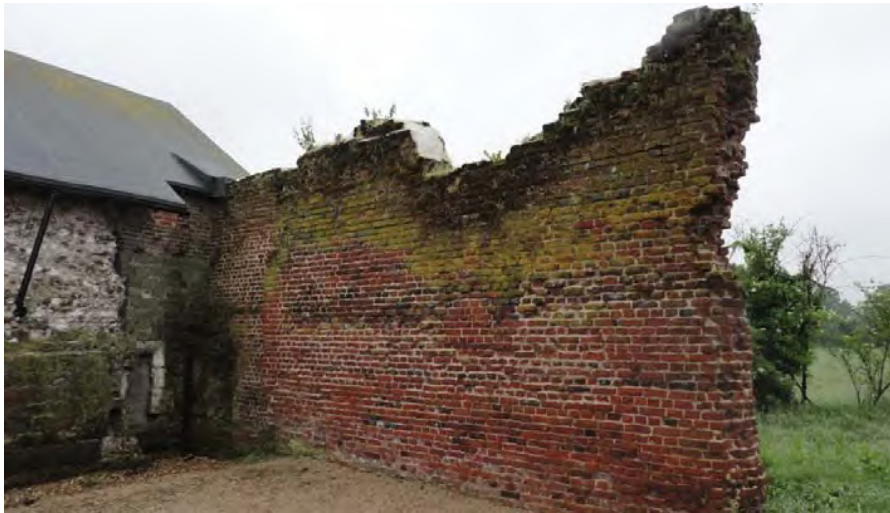
Figure 21. Southern Section East Face of Service Building West Wall showing unsightly white cement mortar capping to wall head and dampness concentrated at wall head due to rainwater run-off; poorly finished area of recent re-pointing in lime mortar.

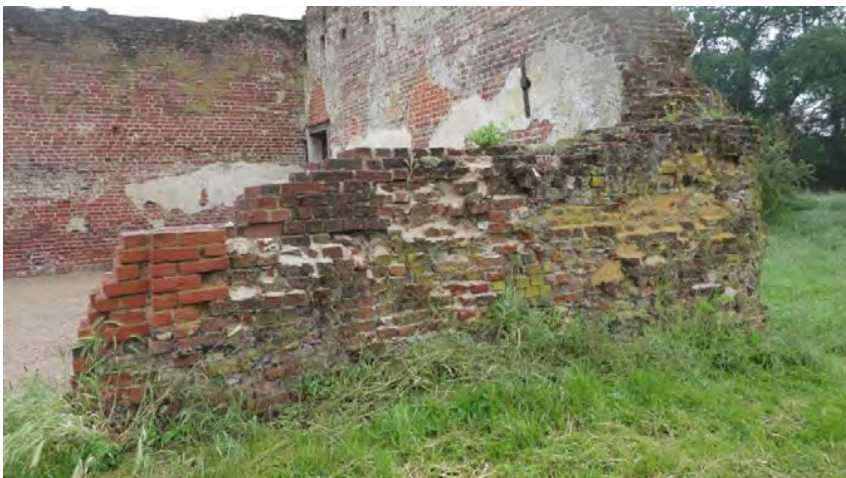
Figure 24. East Face of East Wall of Service Building showing very poor consolidation work. Varying colouration of pointing due to uncontrolled sourcing of sand and bricks to wall end with frogs exposed on upper face of bricks.
